Appendix 3

Site Photographs

Appendix 4

INSPECTION FORM FOR THE POST-CLOSURE AREA AT 1060 E. THIRD ST., BEAUMONT, CA.

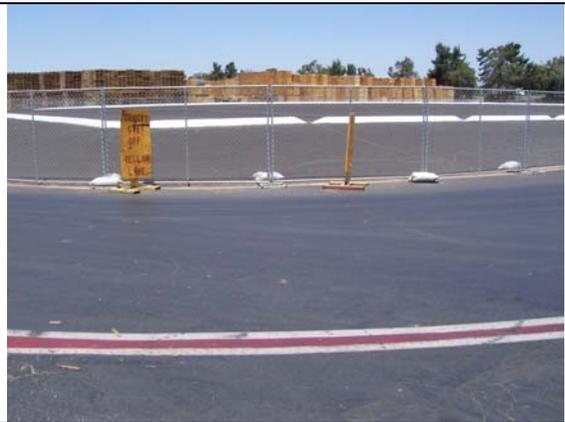
<p>Location: NPCA</p> <p>Photograph: Number 001</p> <p>Description: Looking Northwest from Well Y-4 showing NPCA, temporary fencing and facility roadway.</p>

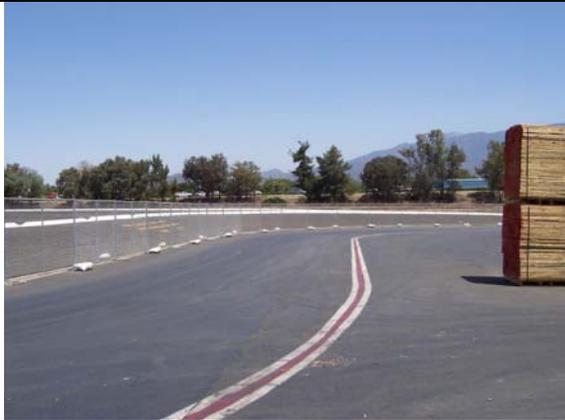
<p>Location: NPCA</p> <p>Photograph: Number 002</p> <p>Description: Looking North from Well Y-4 showing NPCA, temporary fencing and facility roadway.</p>

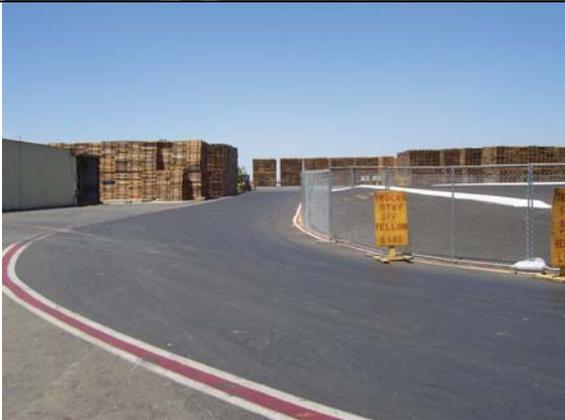
<p>Location: NPCA</p> <p>Photograph: Number 003</p> <p>Description: Looking West from Well Y-4 showing NPCA, temporary fencing and facility roadway.</p>

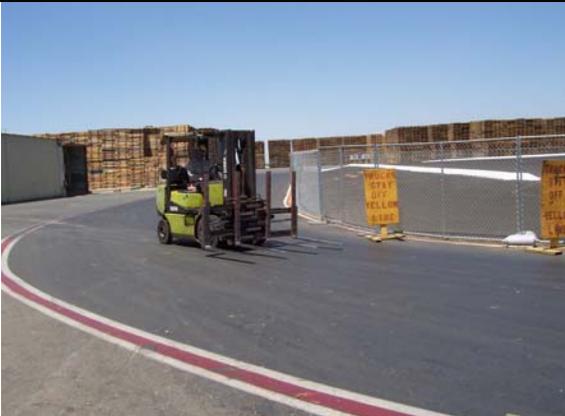
<p>Location: NPCA</p> <p>Photograph: Number 004</p> <p>Description: Looking North from Well Y-4 showing NPCA, temporary fencing and forklift on facility roadway.</p>

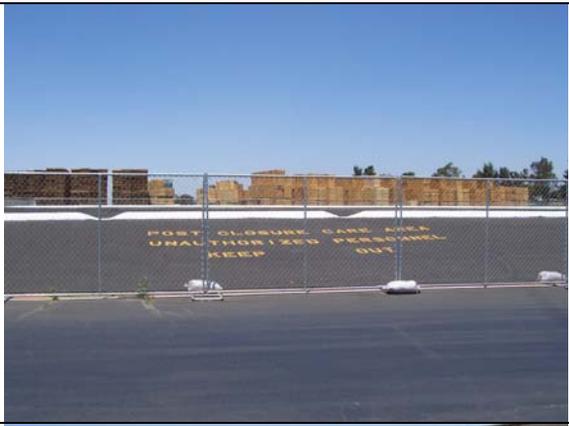
<p>Location: NPCA</p> <p>Photograph: Number 005</p> <p>Description: View of East side of NPCA, temporary fencing and signage on pavement.</p>

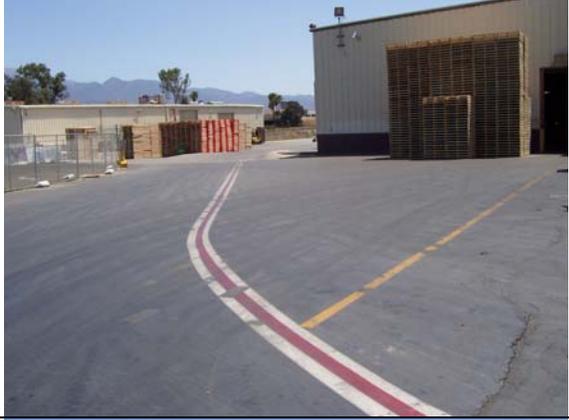
<p>Location: NPCA</p> <p>Photograph: Number 006</p> <p>Description: Looking Northeast at NPCA and facility roadway.</p>

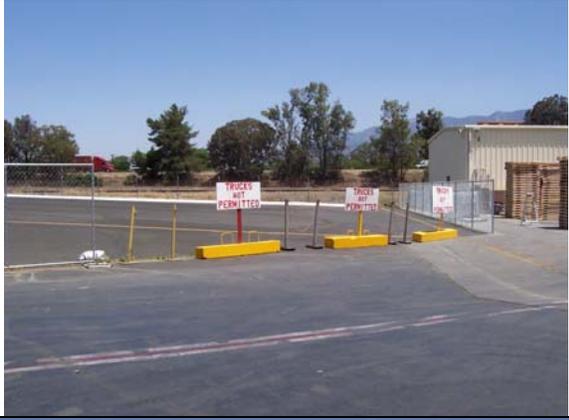
<p>Location: NPCA</p> <p>Photograph: Number 007</p> <p>Description: View of East side of NPCA from Well Y-6 showing temporary fence and access point.</p>

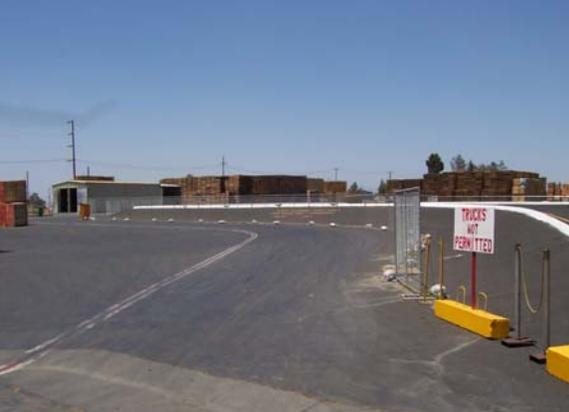
<p>Location: NPCA</p> <p>Photograph: Number 008</p> <p>Description: Looking southwest from Well Y-6 showing NPCA, temporary fencing and access point.</p>

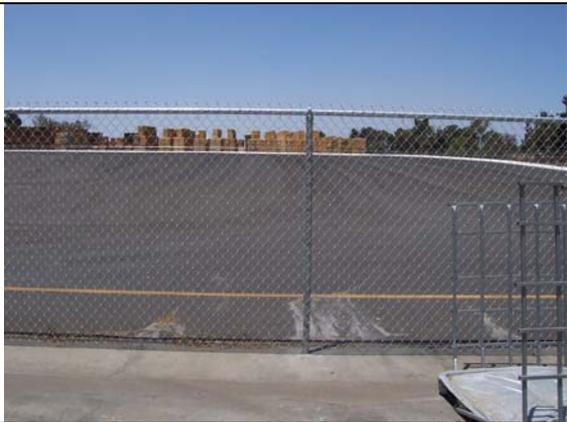
<p>Location: NPCA</p> <p>Photograph: Number 009</p> <p>Description: View of NPCA and fencing north of Well Y-6.</p>

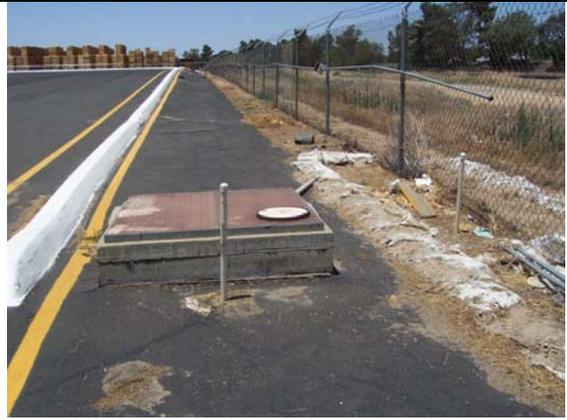
<p>Location: NPCA</p> <p>Photograph: Number 010</p> <p>Description: Looking west along northern fence line with Leak Detection Sump (LDS) in foreground.</p>

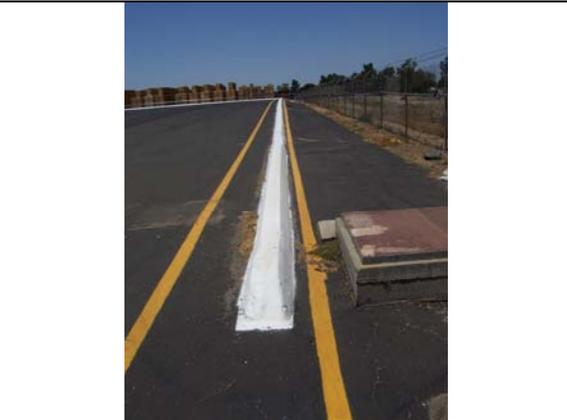
<p>Location: NPCA</p> <p>Photograph: Number 011</p> <p>Description: Close up of 8-inch high asphalt berm along north perimeter of NPCA.</p>

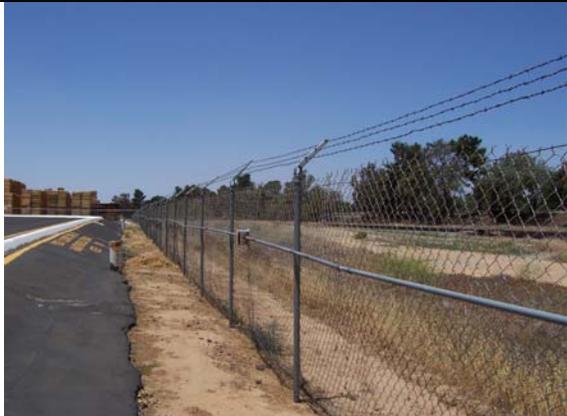
<p>Location: NPCA</p> <p>Photograph: Number 012</p> <p>Description: Looking west along north fence line of NPCA.</p>

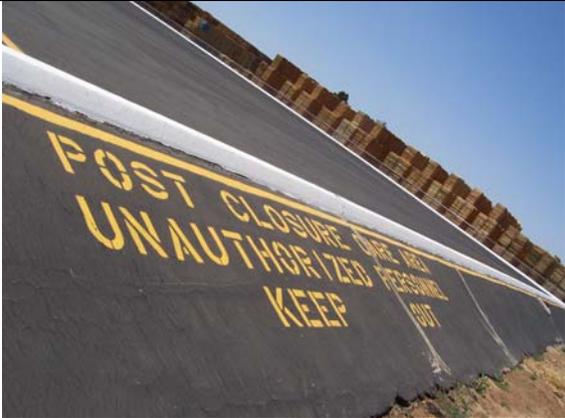
<p>Location: NPCA</p> <p>Photograph: Photograph 013</p> <p>Description: Detail of North slope of NPCA with warning signage.</p>

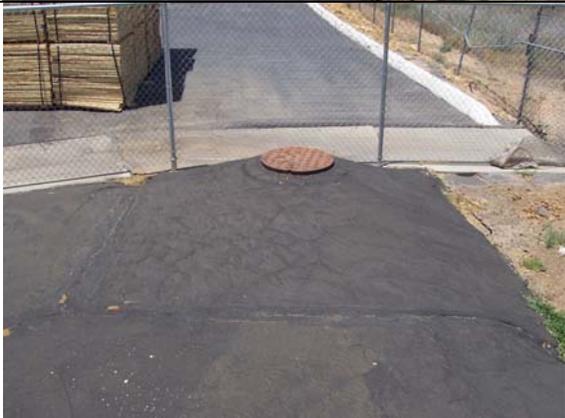
<p>Location: NPCA</p> <p>Photograph: Number 014</p> <p>Description: Sewer manhole at Northwest corner of NPCA and showing concrete swale.</p>

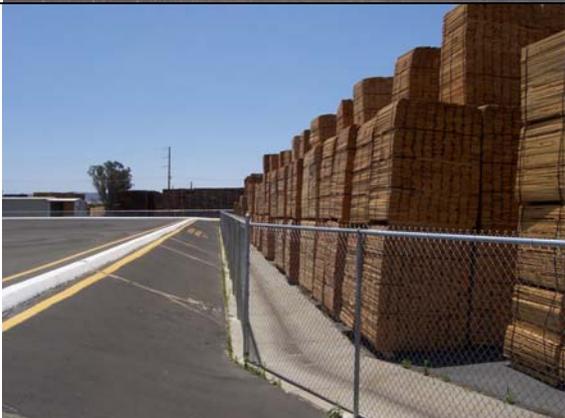
<p>Location: NPCA</p> <p>Photograph: Number 015</p> <p>Description: View looking South along west side NPCA showing fence, concrete swale and exterior material storage.</p>

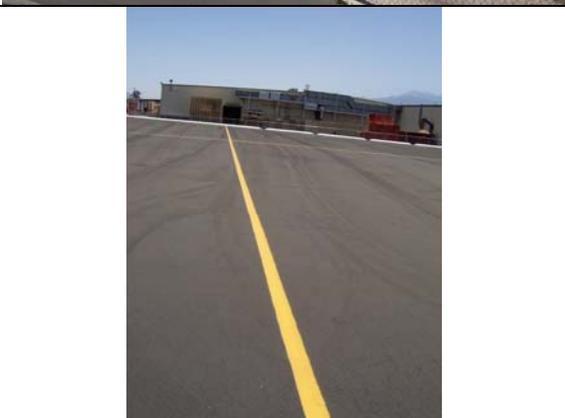
<p>Location: NPCA</p> <p>Photograph: Number 016</p> <p>Description: View within NPCA looking West to East along quadrant line.</p>

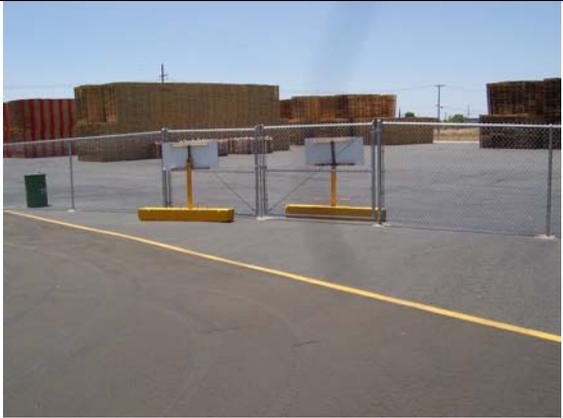
<p>Location: NPCA</p> <p>Photograph: Number 017</p> <p>Description: View of West gate access from interior of NPCA.</p>

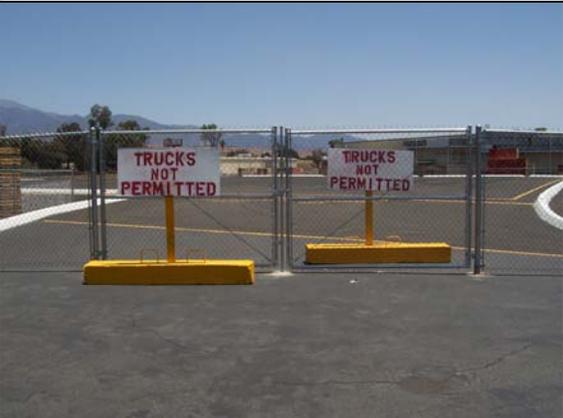
<p>Location: NPCA</p> <p>Photograph: Number 018</p> <p>Description: View of West gate access from exterior of NPCA.</p>

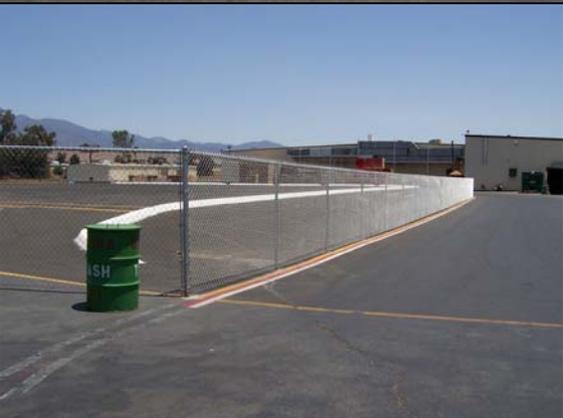
<p>Location: NPCA</p> <p>Photograph: Number 019</p> <p>Description: View of Southwest corner of NPCA, fencing, and facility roadway.</p>

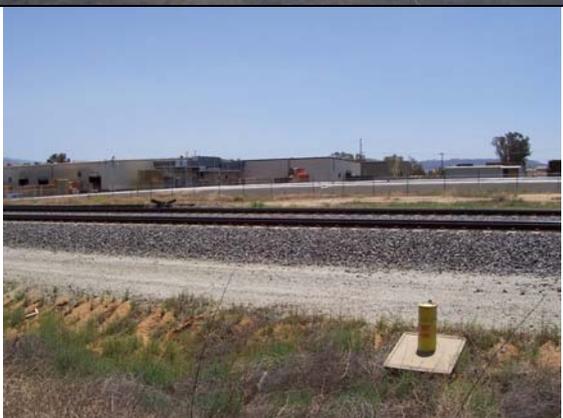
<p>Location: NPCA</p> <p>Photograph: Number 020</p> <p>Description: South view of NPCA from Well SDB-6B and railroad tracks</p>
