Palos Verdes Unified School District
property at 32201 Forrestal Drive,
Rancho Palos Verdes, California

Docket # HWCA20167265

ORDER TO FENCE AND POST

Re: Summary Report – Limited Soil Sampling of Imported and Stockpiled Soils at the Ladera Linda Park, Upper Field, 32201 Forrestal Drive, Rancho Palos Verdes, California 90275

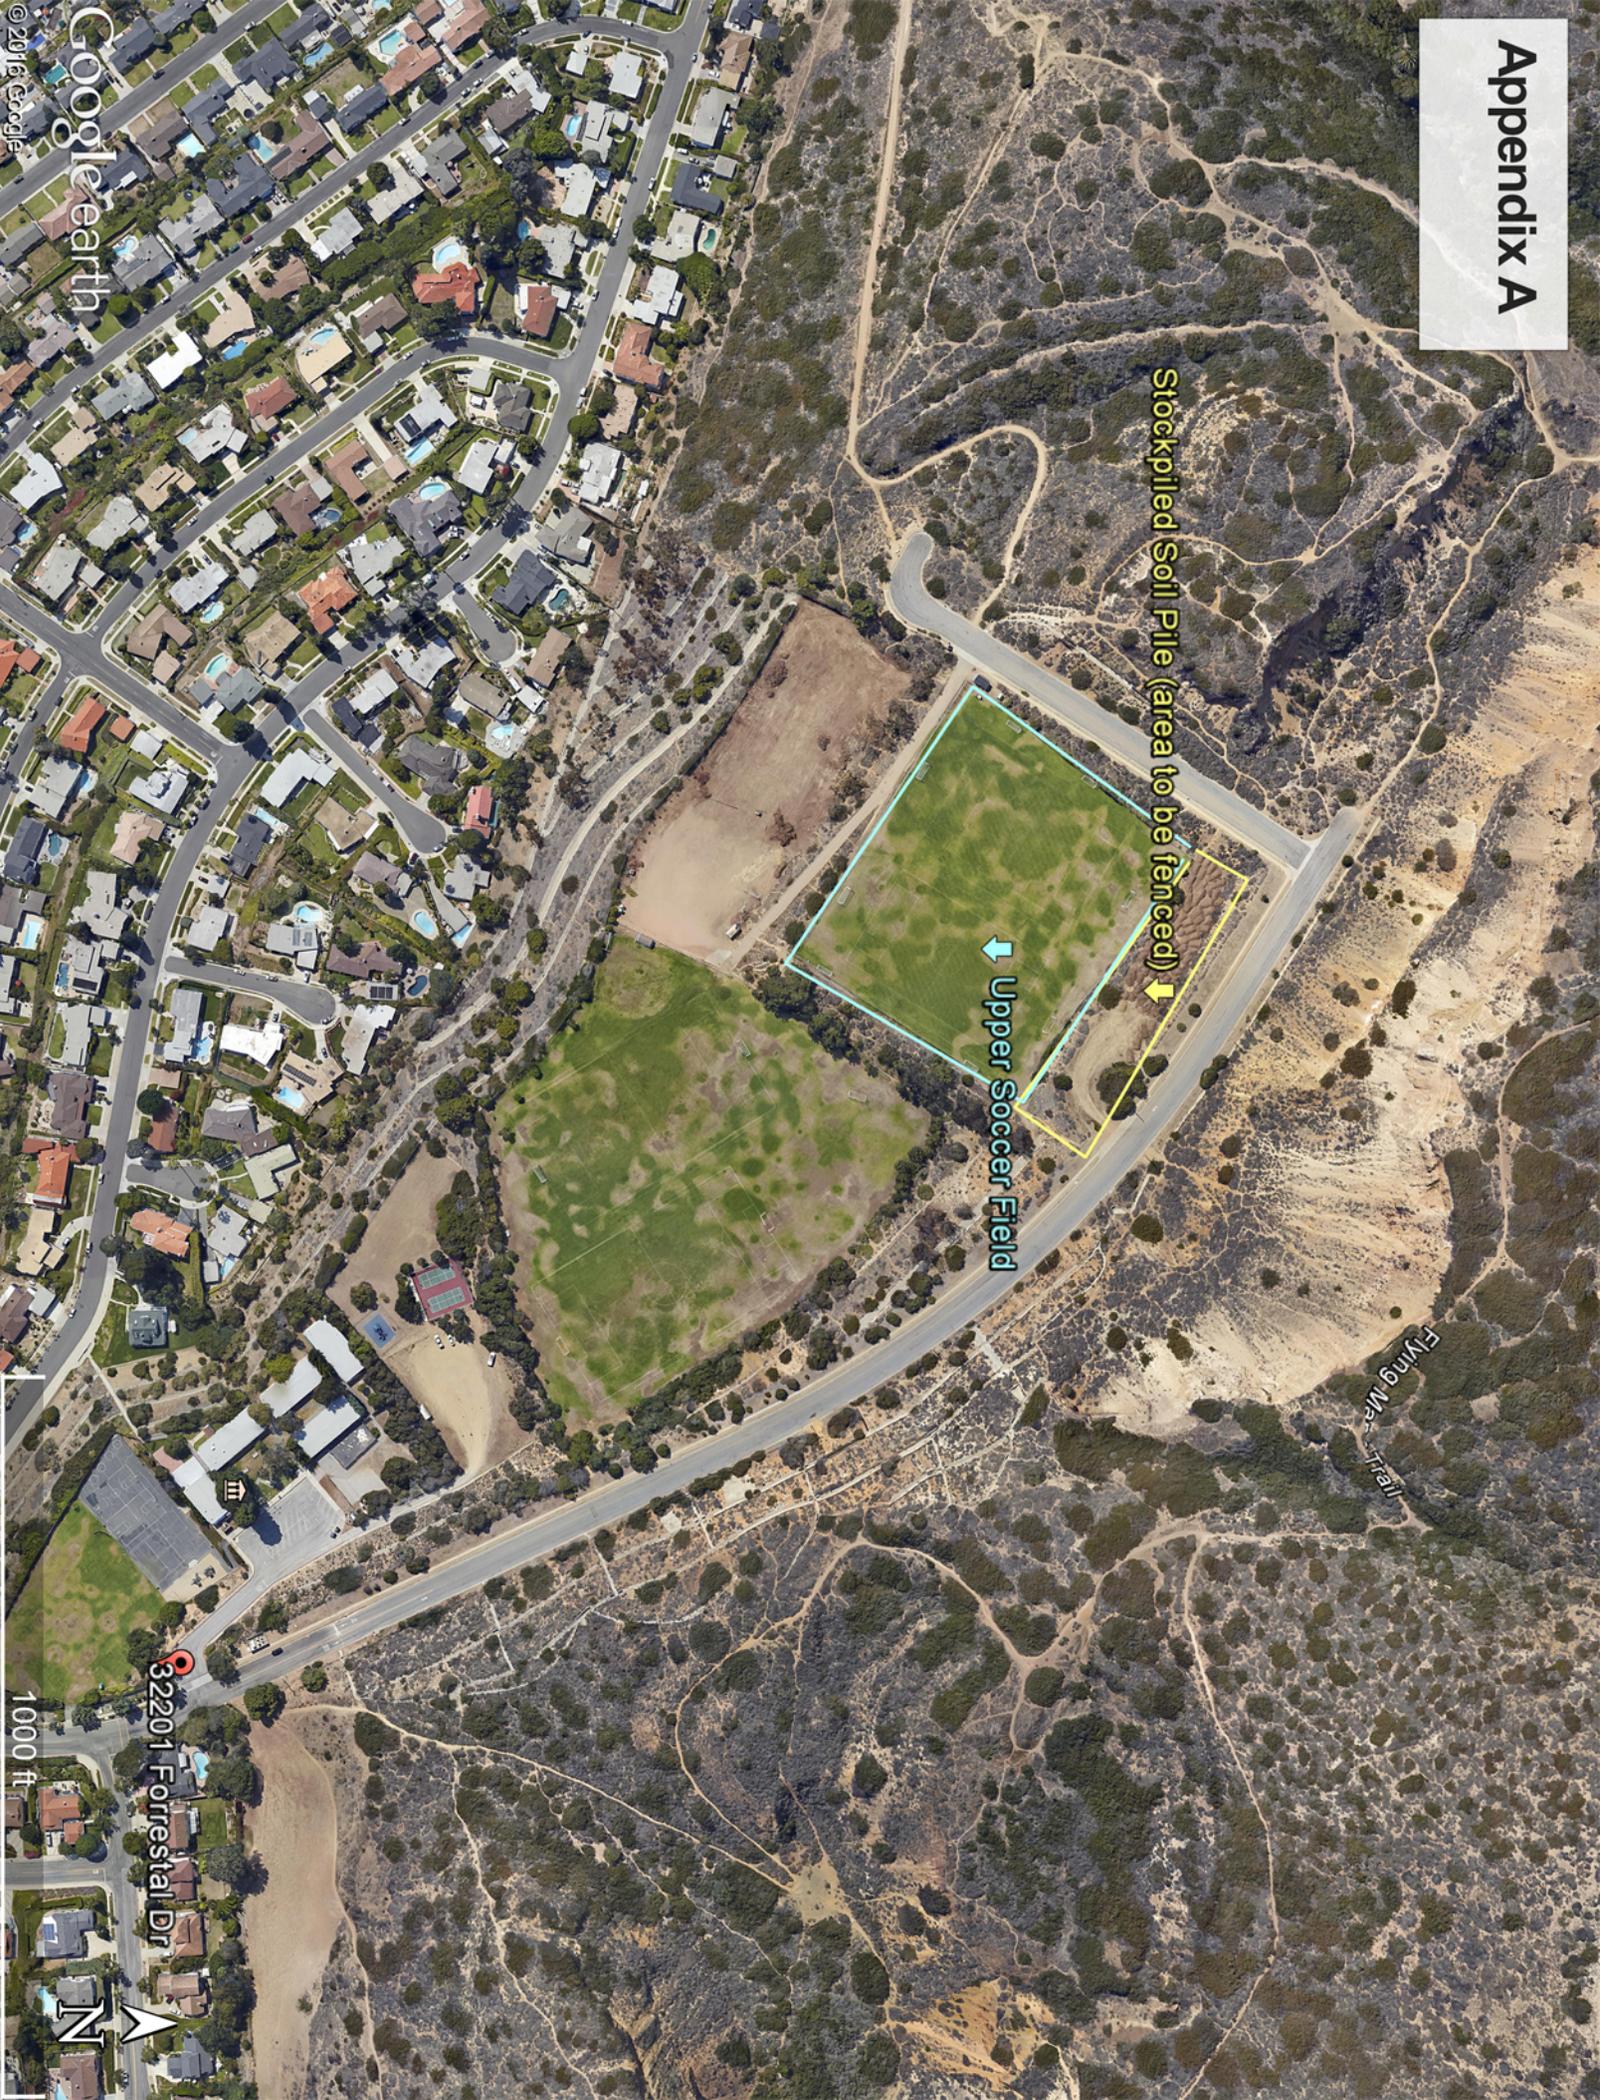
Stockpiled Soil Pile (area to be fenced)

17. Respondent shall install a fence on the Site to secure, at a minimum, the area specified on the Site map (Appendix "A") identified as "Stockpiled Soil Pile", and any other area where soil from this Stockpiled Soil Pile has been deposited.

Additionally, the Stockpiled Soil Pile, and any parts of the soccer field in which soil from the Stockpiled Soil Pile was used as fill, must be covered with heavy duty fabric weight plastic sheeting. The existing chain link fence surrounding the Upper Soccer Field, as

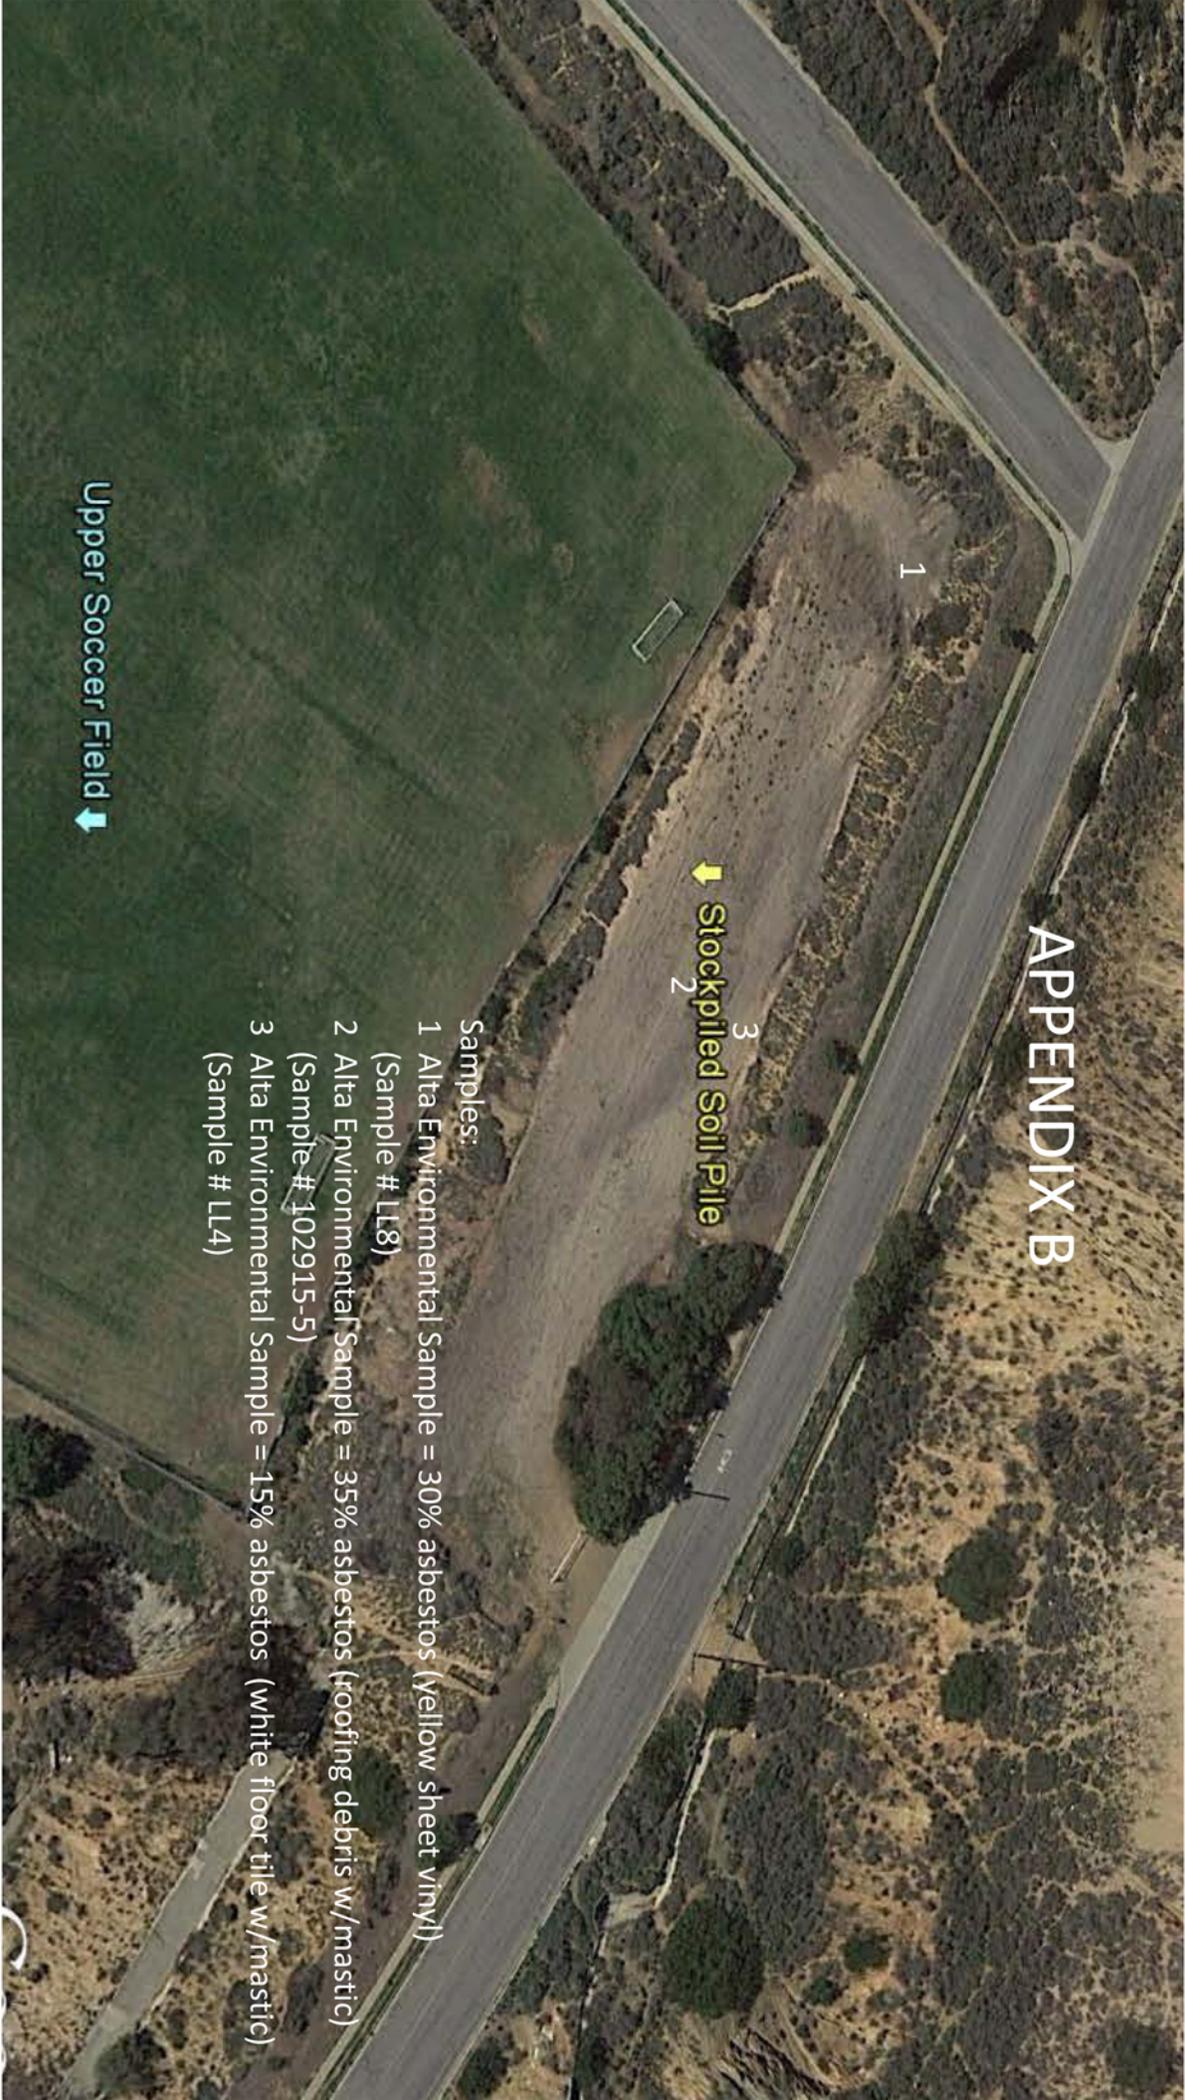
APPENDIX B

Samples:

- 1 Alta Environmental Sample = 30% asbestos (yellow sheet vinyl)
(Sample # LL8)
- 2 Alta Environmental Sample = 35% asbestos (roofing debris w/mastic)
(Sample # 102915-5)
- 3 Alta Environmental Sample = 15% asbestos (white floor tile w/mastic)
(Sample # LL4)
