## **Deliverable No. 2**

# **Remedial Investigation Workplan Fieldstone Property Consent Order Docket No. HSA-CO 01/02-154**

**21 July 2003**

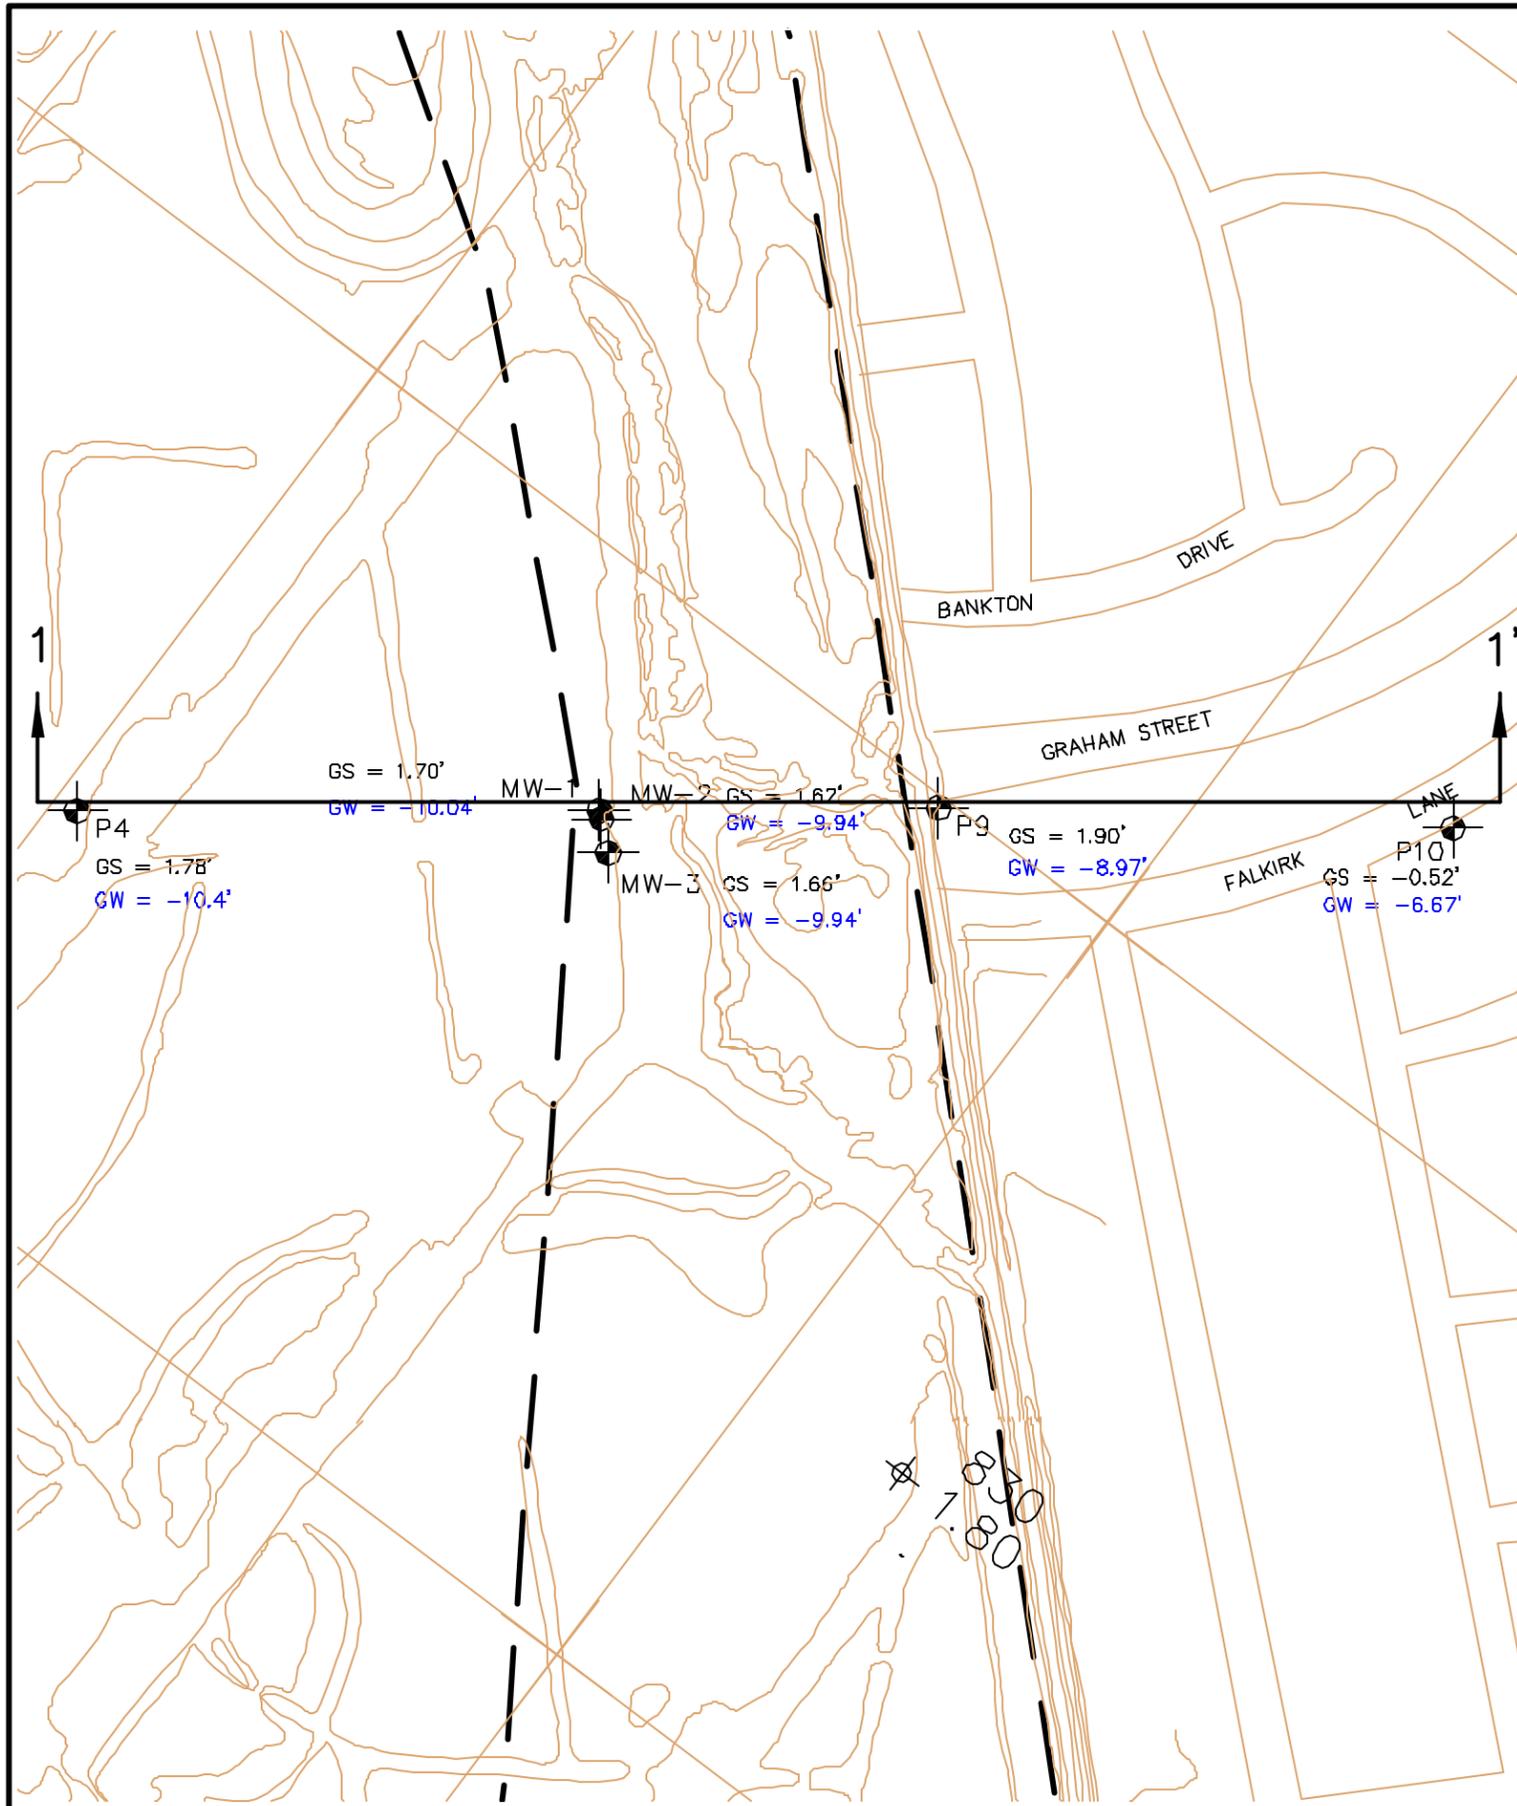
FIGURE NO.	2-6
PROJECT NO.	HR0653-01
DOCUMENT NO.	
DATE:	FEBRUARY 2003

HYDROGEOLOGIC LAYOUT  
BOLSA CHICA LOWLAND  
ORANGE COUNTY, CALIFORNIA

The upper soil profile at the Site consists of predominantly silts and clays. Figures 2-6 and 2-7 show a hydrogeologic cross section, which illustrates subsurface geologic and hydrogeologic conditions at the Site. This cross-section was constructed based on lithologic interpretations of borehole and CPT sounding logs completed as part of previous hydrologic investigations of the Bolsa Chica Lowlands [GeoSyntec, 2000; Woodward-Clyde, 1991; Earth Tech, 1991; Bilhorn, 1986].

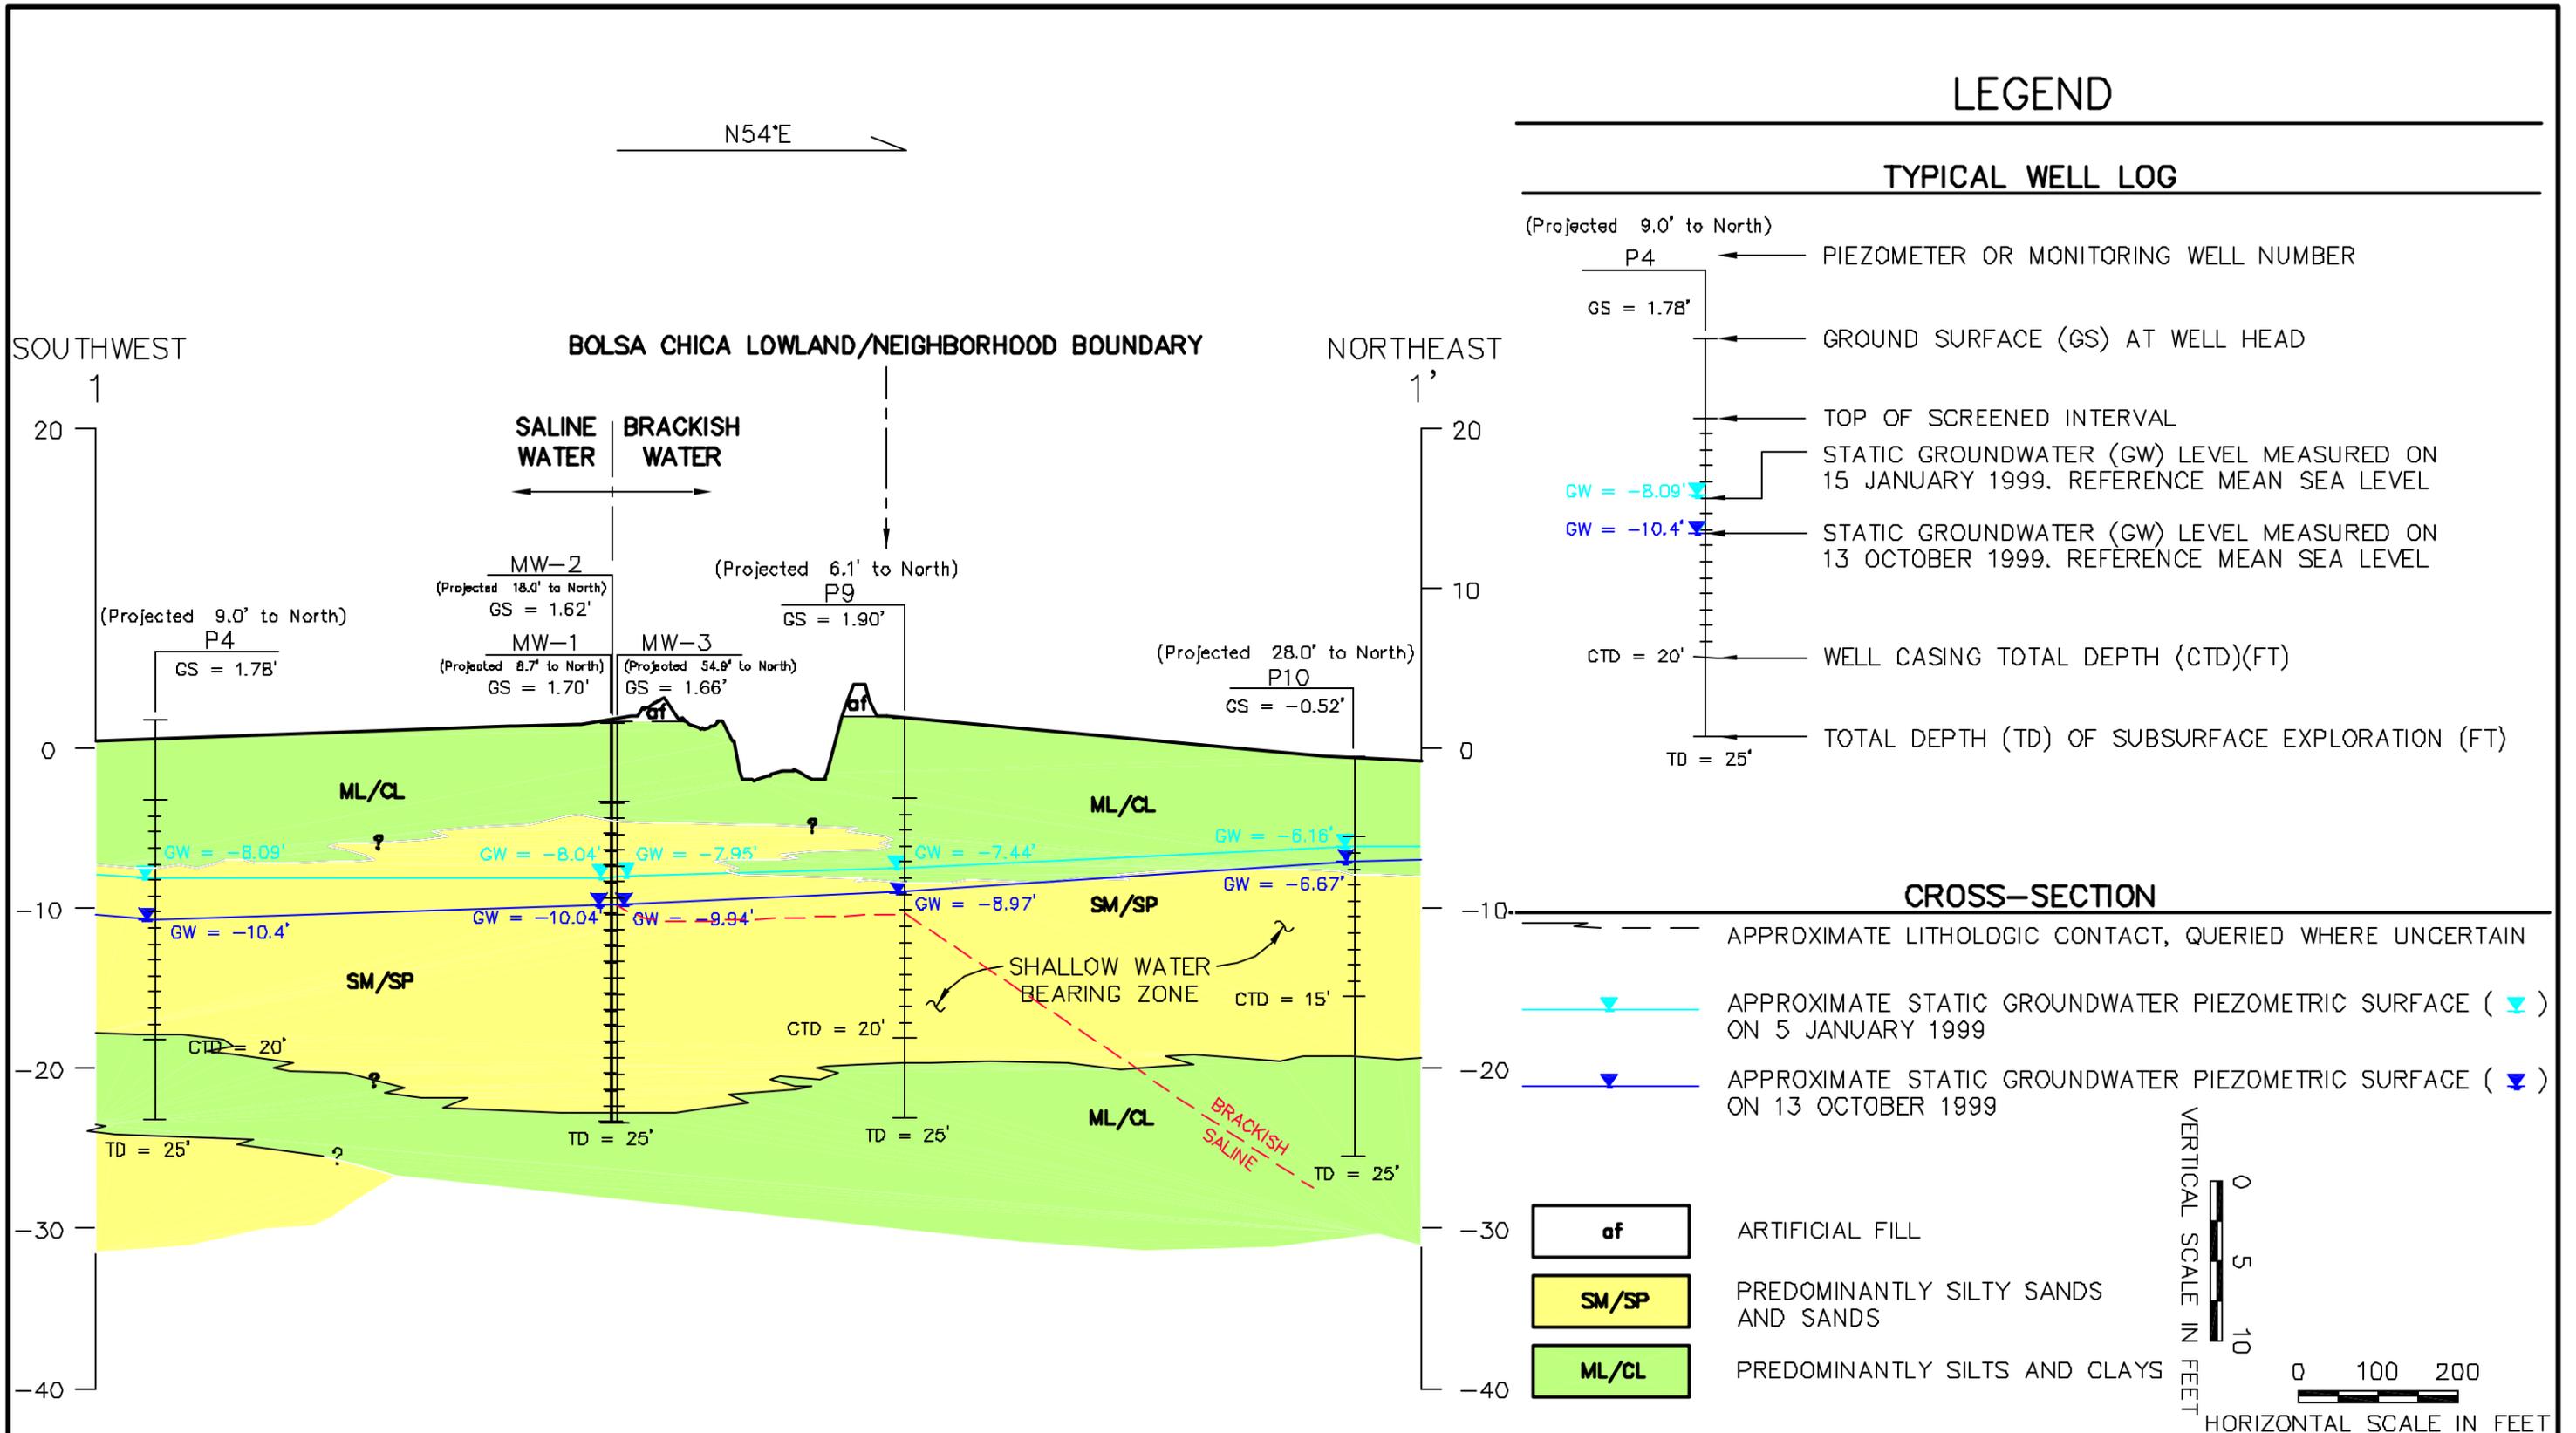
HYDROGEOLOGIC CROSS SECTION1-1' BOLSA CHICA LOWLAND ORANGE COUNTY, CALIFORNIA	FIGURE NO. 2-7
	PROJECT NO. HR0653-01
	DOCUMENT NO.
	DATE: FEBRUARY 2003

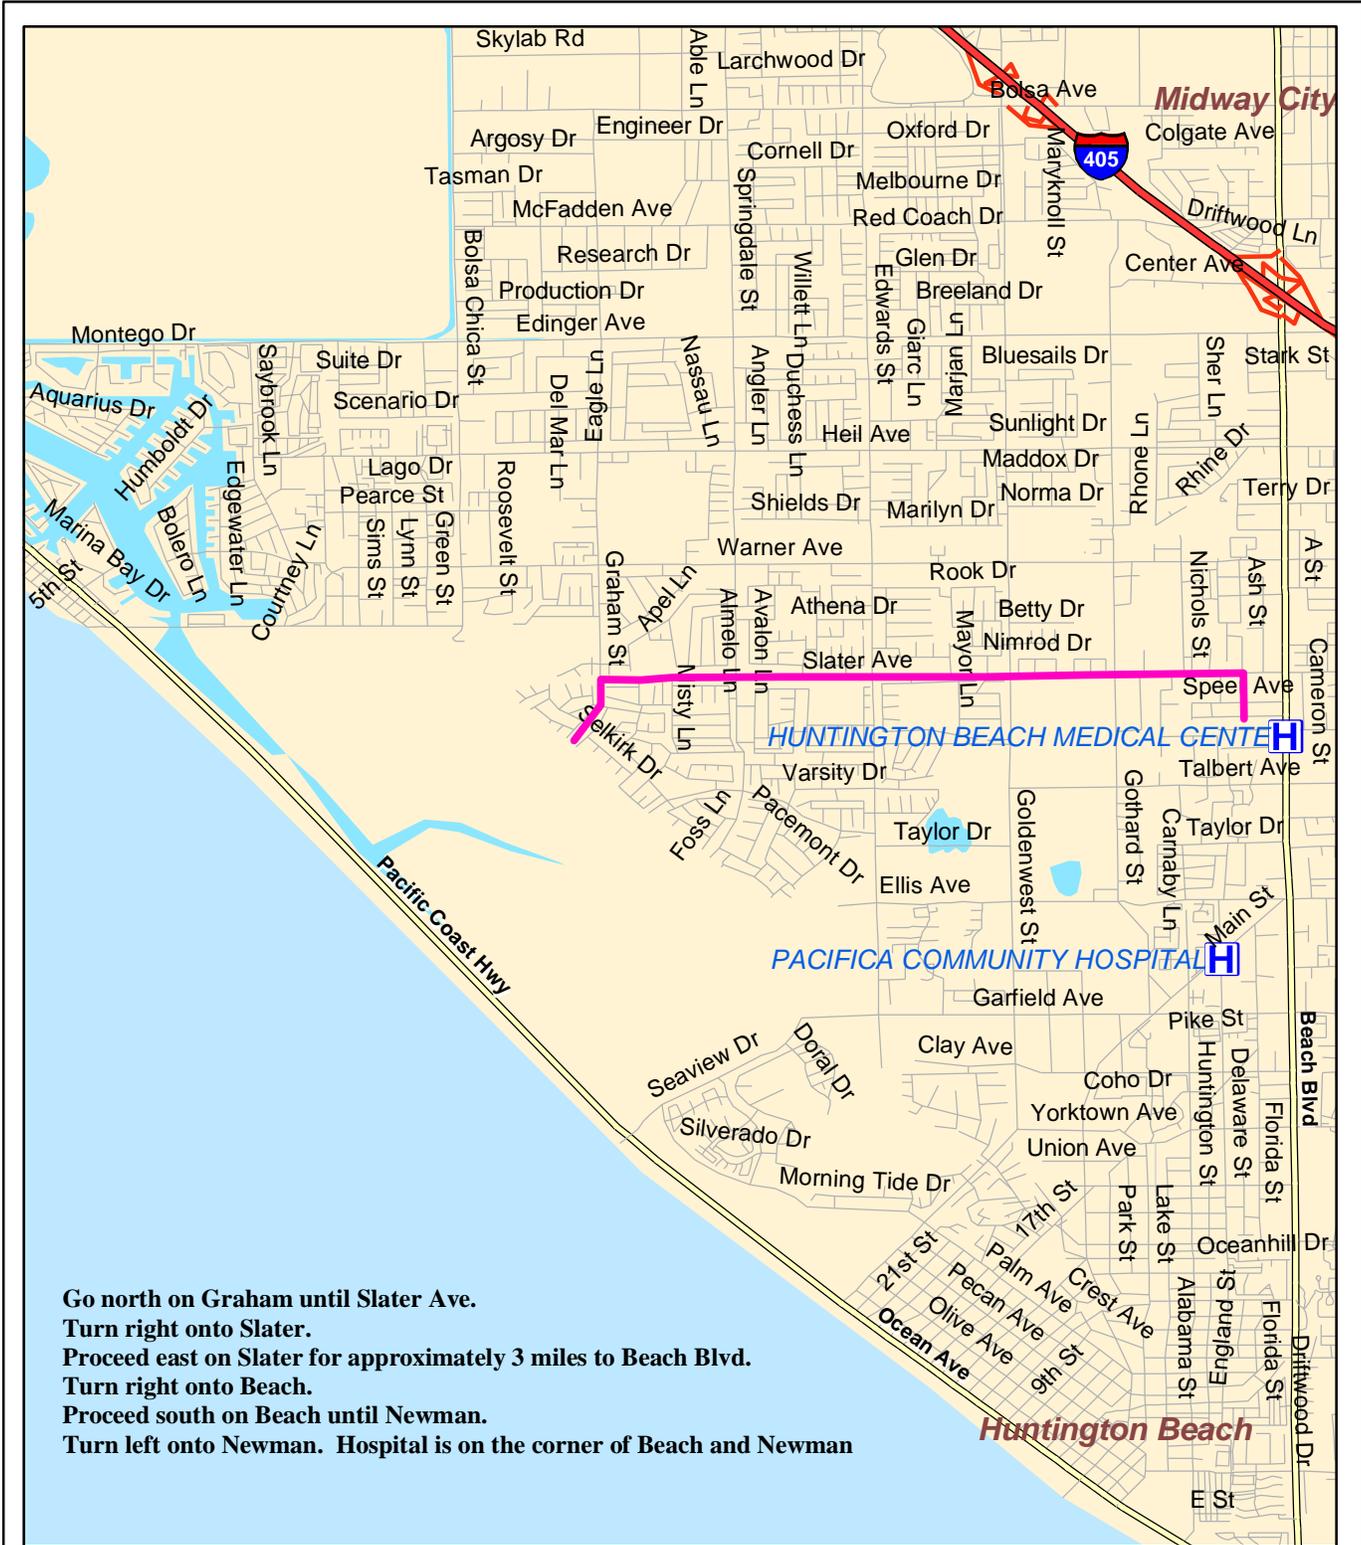
PROJECT:	FIELDSTONE	
TITLE:	SITE AREA MAP Huntington Beach, California	
FIGURE:	1	DOCUMENT NO.: 02-21
PROJECT:	HR0653	DATE: 20 FEB 2003

An agreed-upon method of communicating evacuation orders (such as use of horn or siren) must be established and explained to personnel at the pre-entry briefing (Section 3.2). In the case evacuation becomes necessary, personnel shall follow the established evacuation routes shown to the rally point (Figure 1) staying upwind of airborne hazards.

A Site map is included in Figure 1. A map of the route to the nearest hospital is included in Figure 2. The following items are included on the Site map.
