| JOB NUMBER | Baxter Court, San Rafael, California | TOTAL DEPTH OF HOLE | JPD |

**Soil Sampling Results for Selected Metals**
Facility Investigation Report
Baxter Court and Thomas Properties
694 and 720 West Francisco Boulevard
San Rafael, California

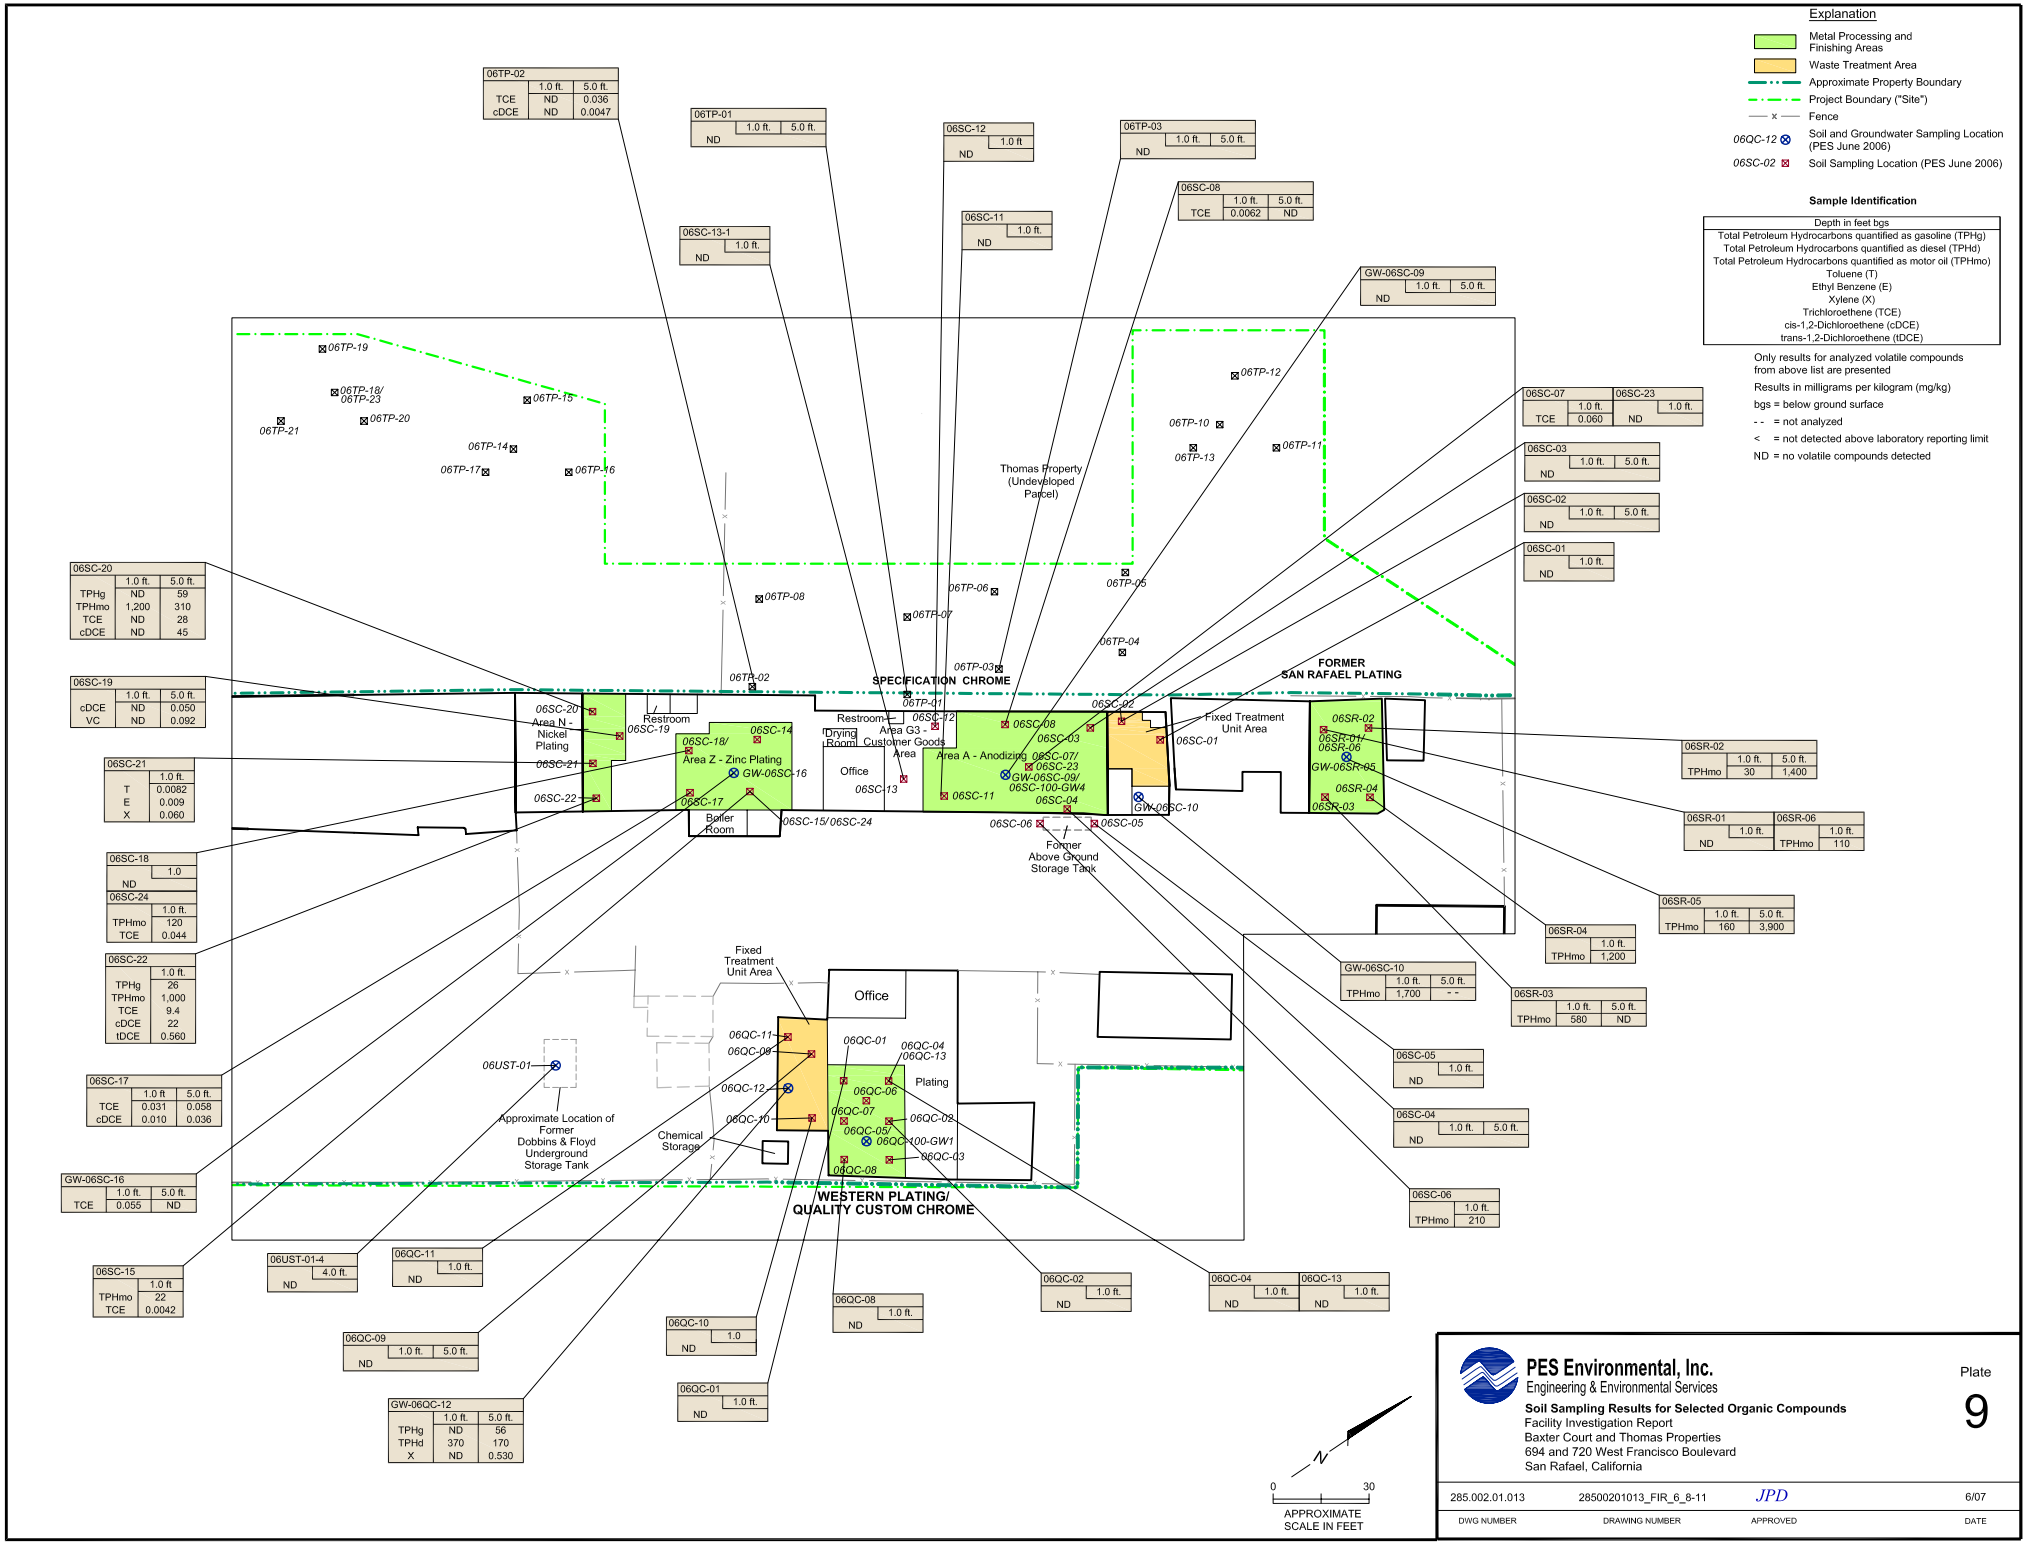
Plate
9

**Soil Sampling Results for Selected Organic Compounds**
Facility Investigation Report
Baxter Court and Thomas Properties
694 and 720 West Francisco Boulevard
San Rafael, California

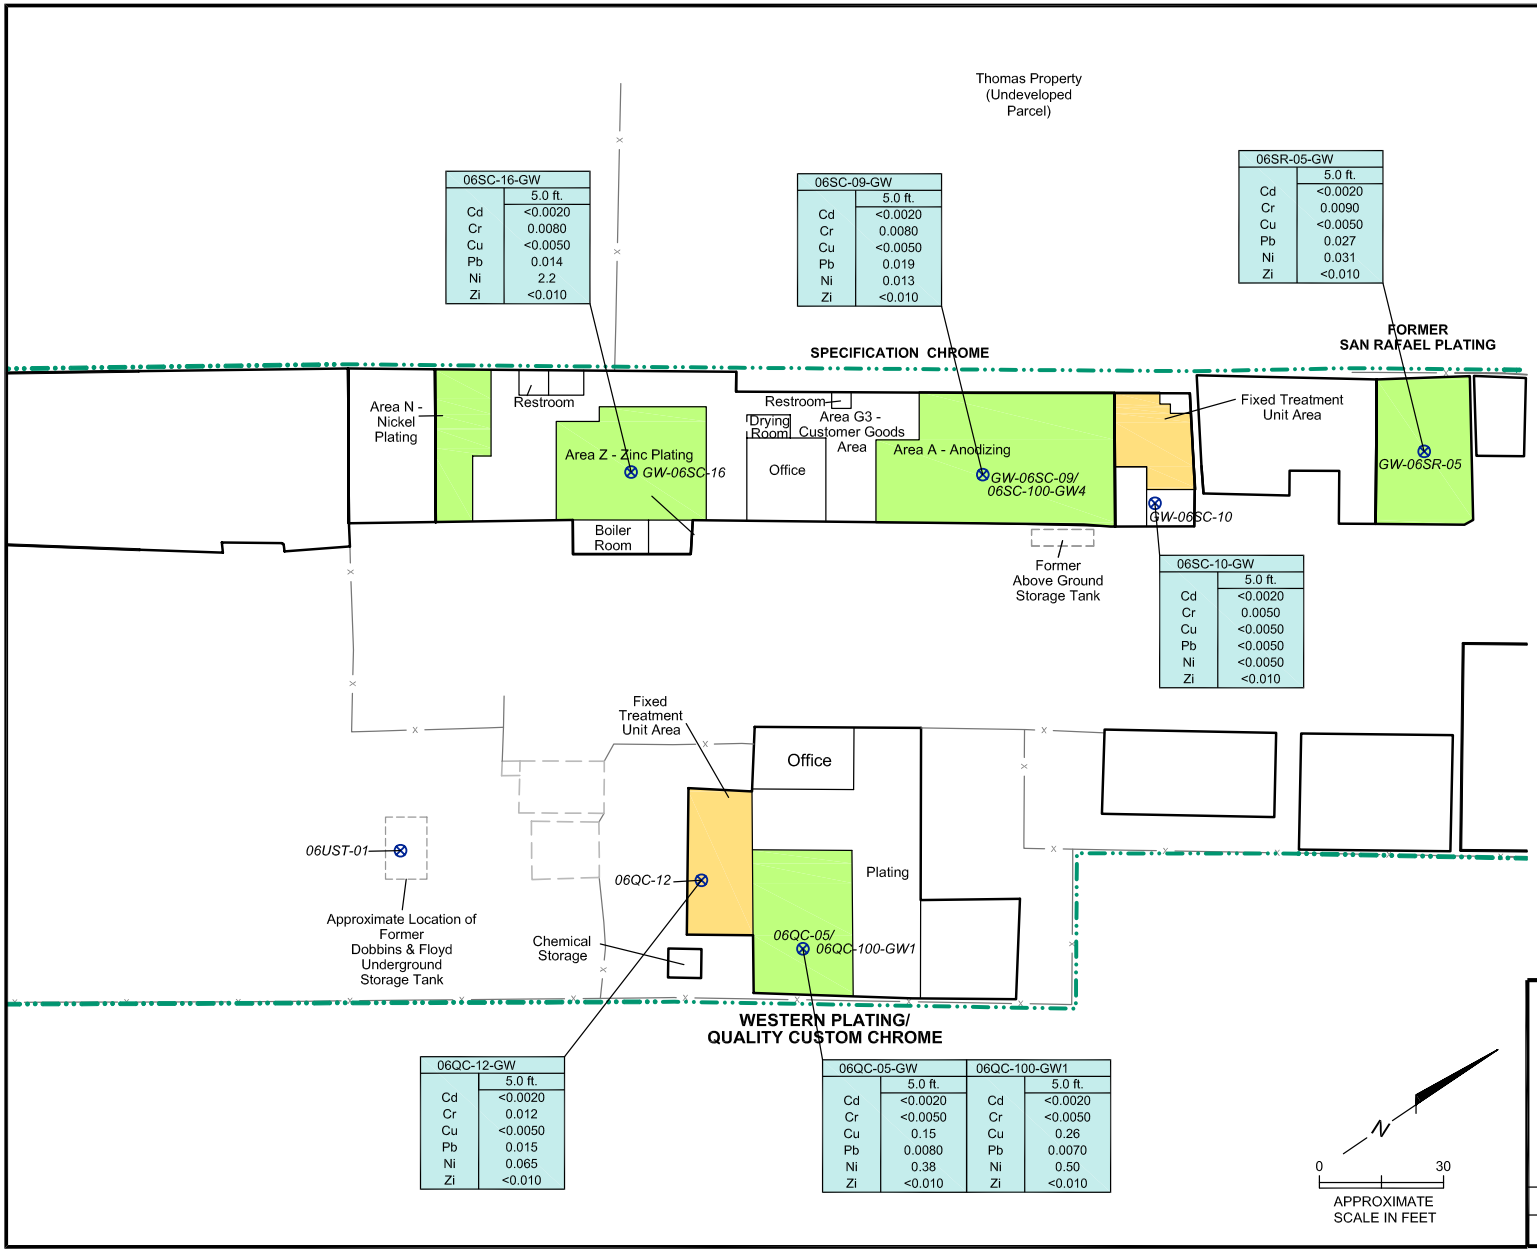
PLATE
10

| 06SC-16-GW | 5.0 ft. |
|---|---|
| Ni | 2.2 |

| 06QC-05-GW | 5.0 ft. | 06QC-100-GW1 | 5.0 ft. |
|---|---|---|---|
| Cu | 0.15 | Cu | 0.26 |
| Ni | 0.38 | Ni | 0.50 |

**Groundwater Sampling Results for Selected Metals**
Facility Investigation Report
Baxter Court and Thomas Properties
694 and 720 West Francisco Boulevard
San Rafael, California

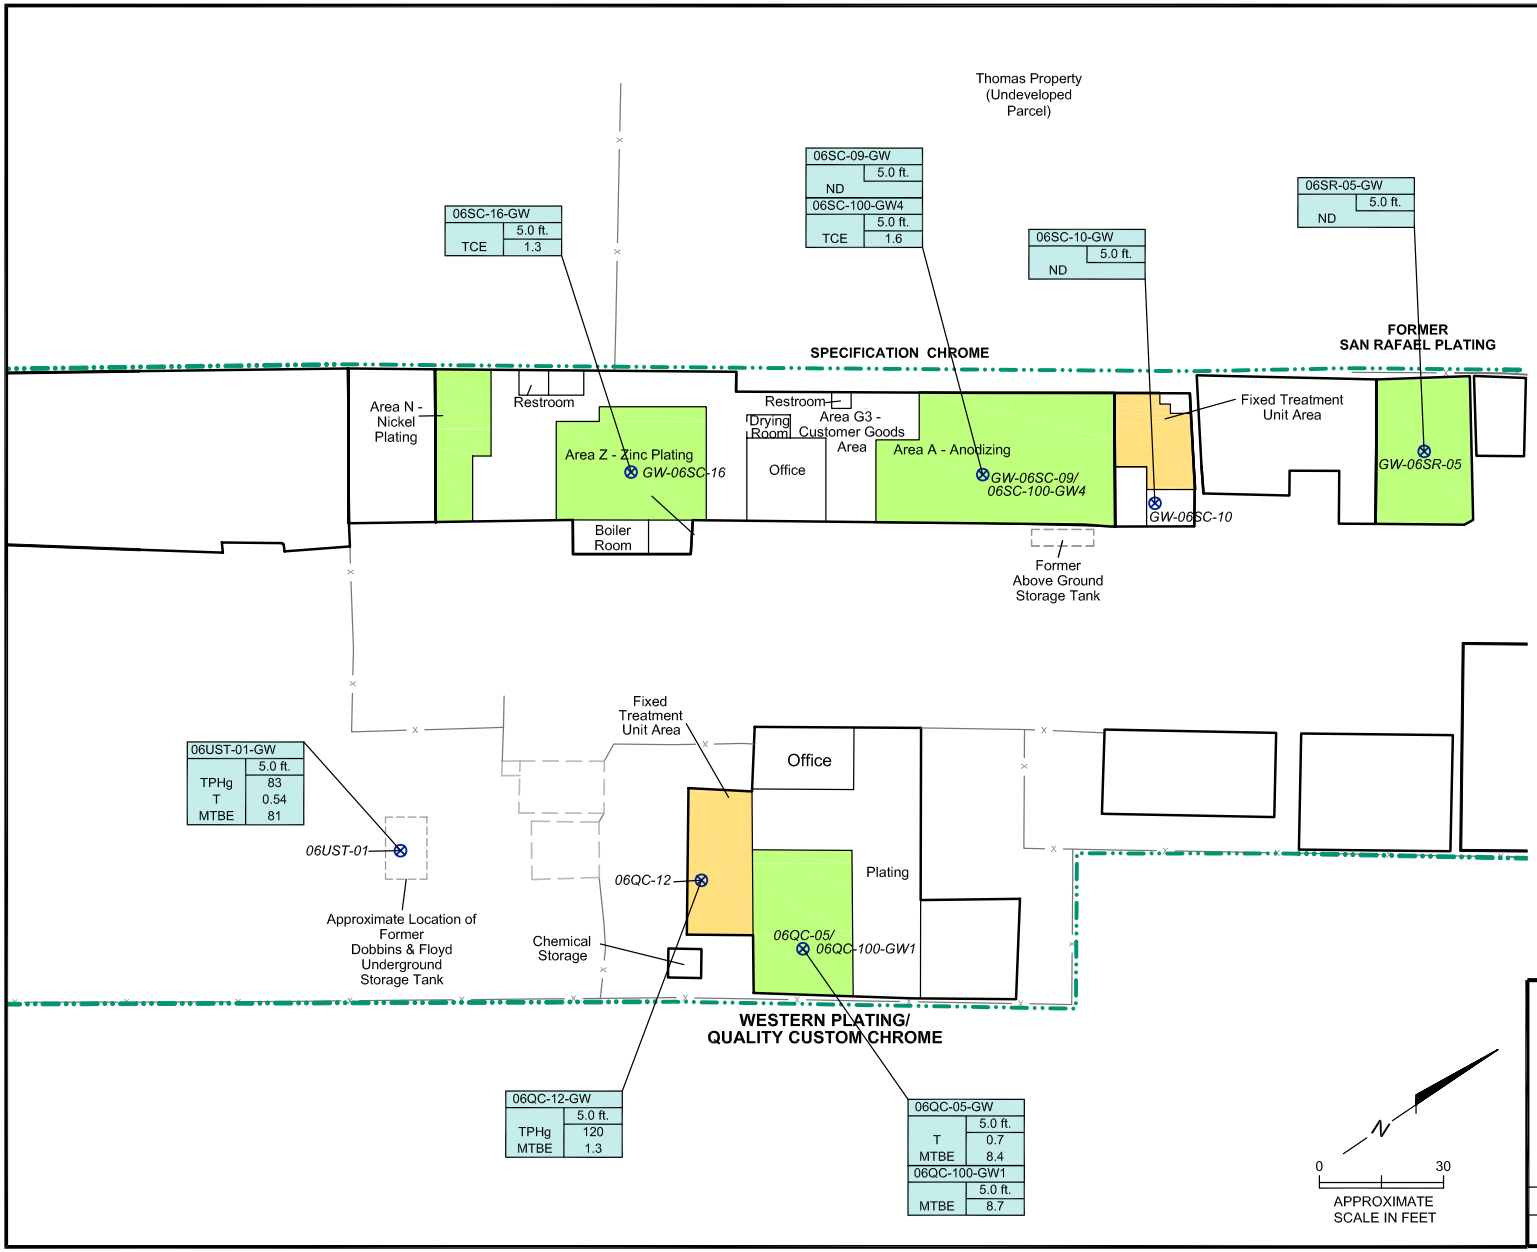
PLATE
11

**Groundwater Sampling Results for Selected Volatile Organics**
Facility Investigation Report
Baxter Court and Thomas Properties
694 and 720 West Francisco Boulevard
San Rafael, California

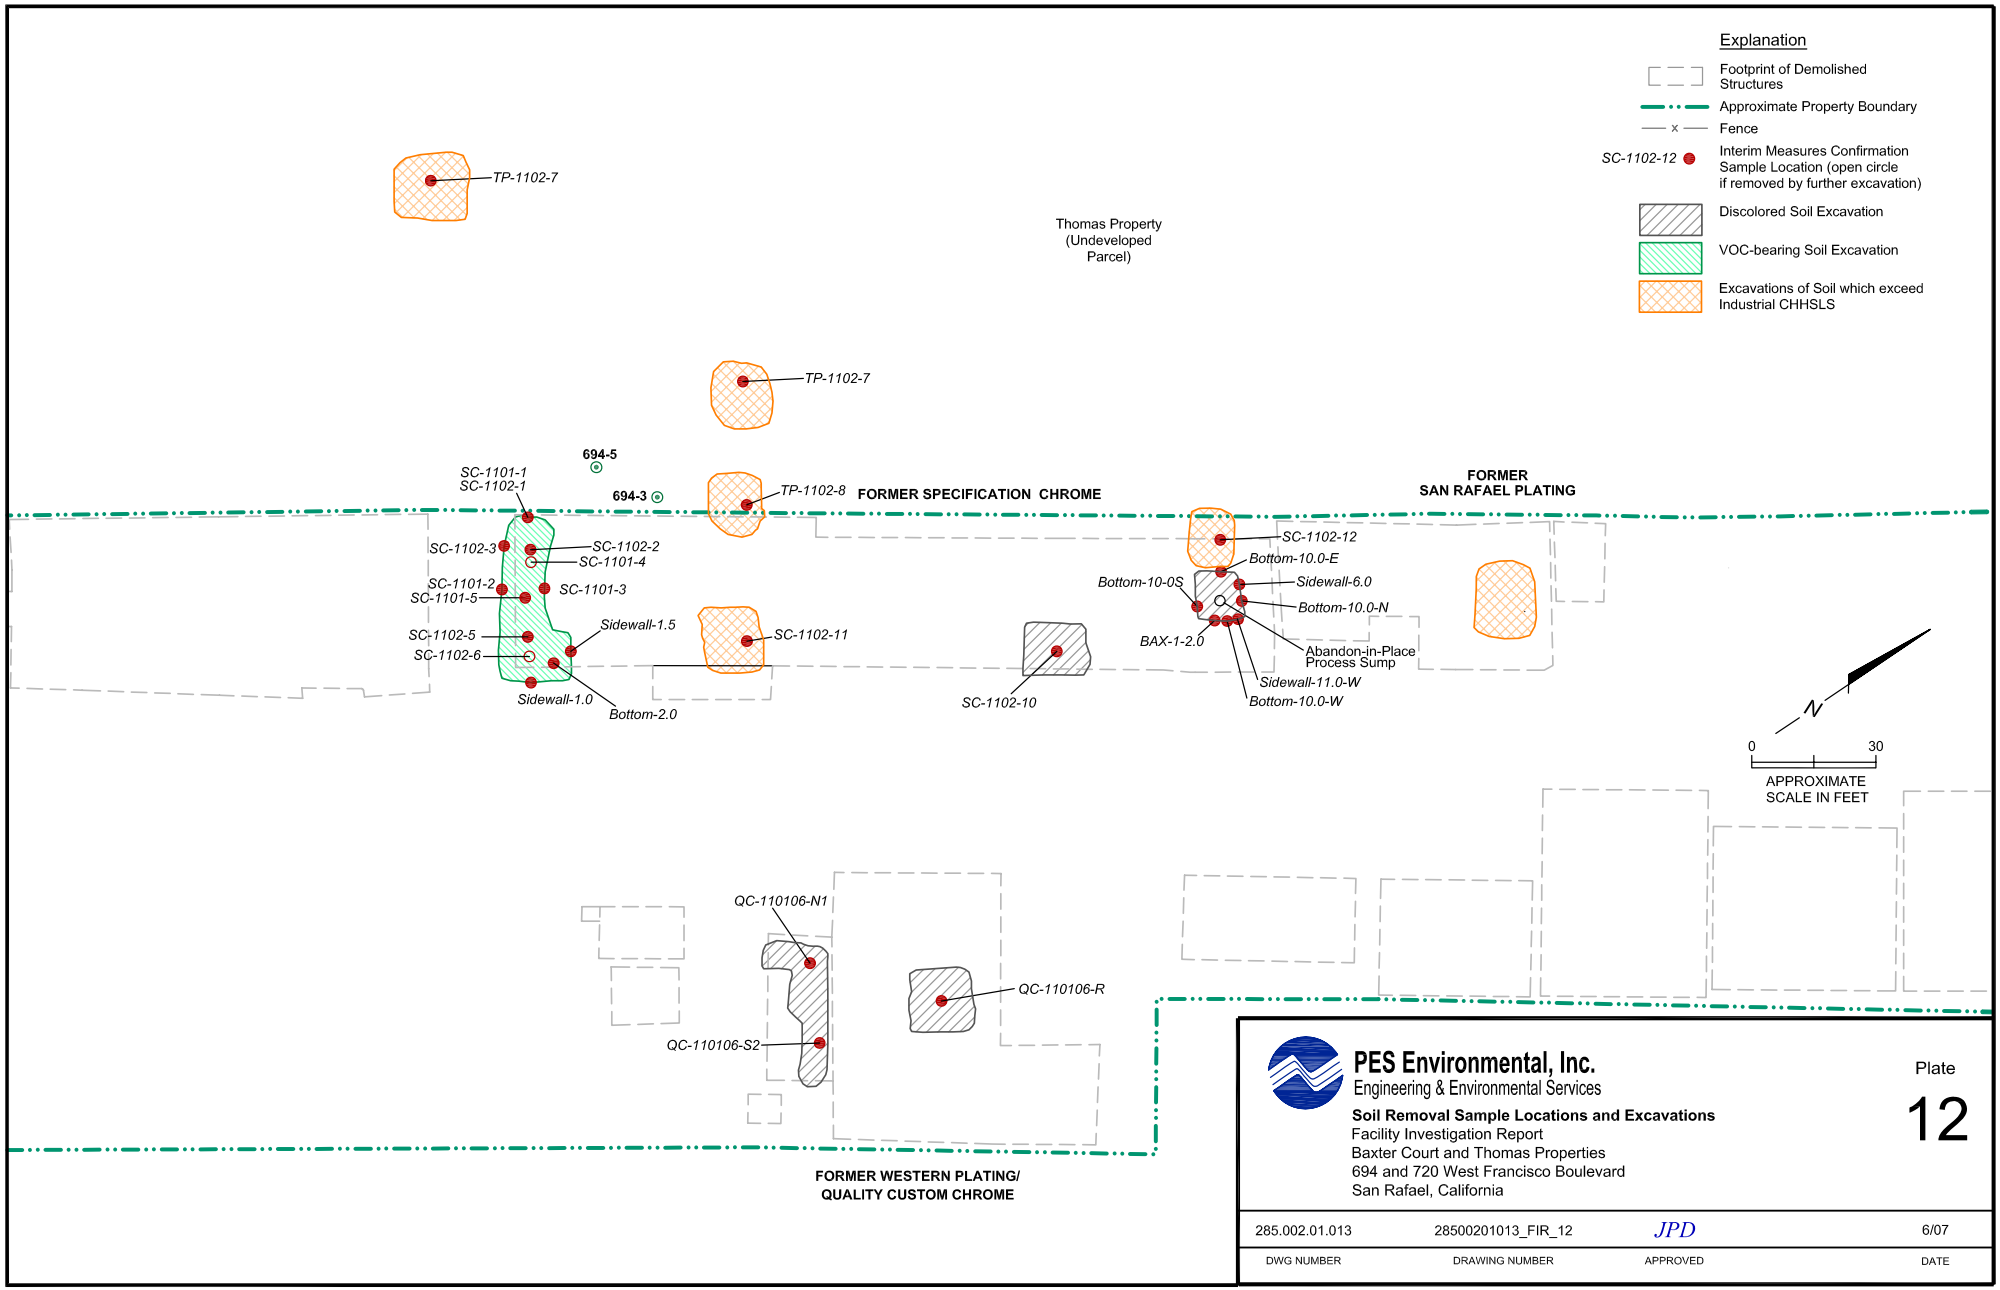
Plate
12

**Soil Removal Sample Locations and Excavations**
Facility Investigation Report
Baxter Court and Thomas Properties
694 and 720 West Francisco Boulevard
San Rafael, California

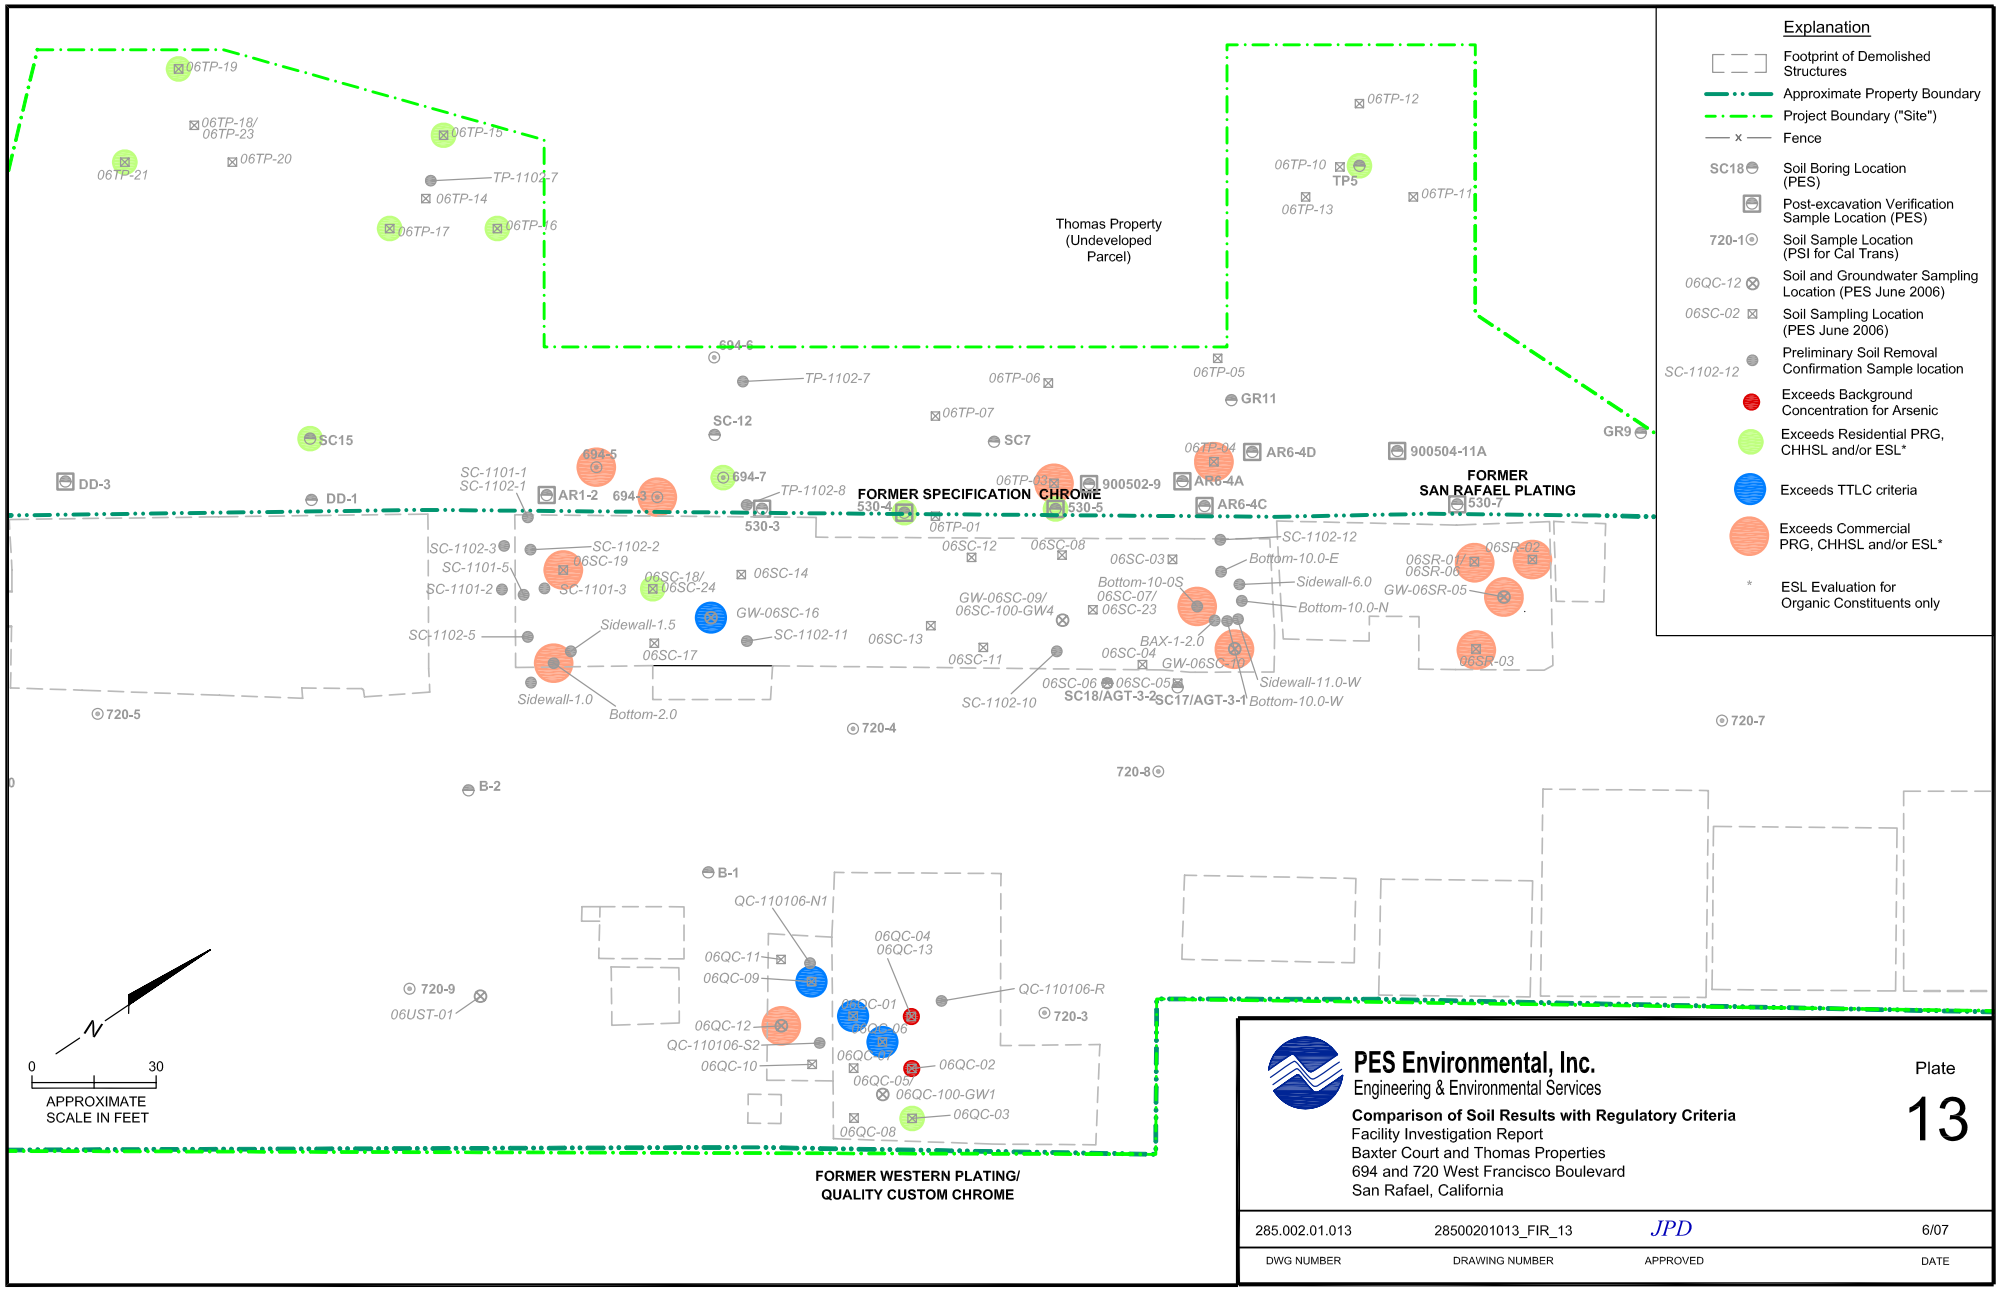
Plate 13

**Comparison of Soil Results with Regulatory Criteria**
Facility Investigation Report
Baxter Court and Thomas Properties
694 and 720 West Francisco Boulevard
San Rafael, California
