Safer Alternatives to Copper Antifouling Paints: Nonbiocide Paint Options

Prepared for:
Cal/EPA's Department of Toxic Substances Control and
U.S. Environmental Protection Agency Region IX

Prepared by:
Katy Wolf
Institute for Research and Technical Assistance

February 2011

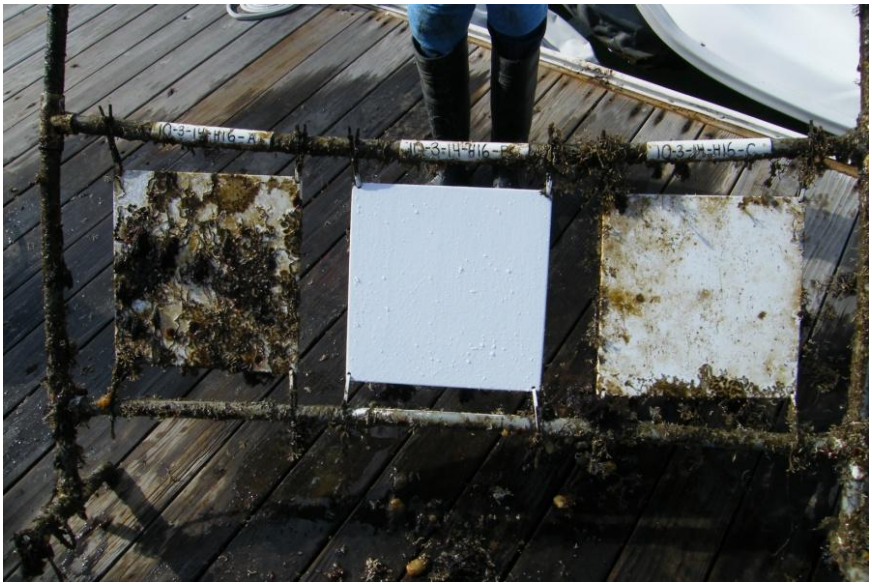
This paint is also a silicon based foul release paint with a fluoropolymer added. The panel testing sheets indicate that it performed better than the other Klear N' Klean formulation in the panel testing. The two panels that were cleaned were cleaned readily and the coating condition was good until the last inspection when some scratches were noted. A picture of the three panel assembly in January 2011, about halfway through the test period, is shown in Figure 3-4. Again, because the paint includes the ingredient which has been removed from the market, it is not a candidate for boat testing. Petit, the paint supplier, did reformulate the paint with a new fluoropolymer ingredient and the reformulated paint which has the same name was selected for boat testing.

Source: POSD, 2011
Figure 3-4. XP-A101 Paint During Panel Testing

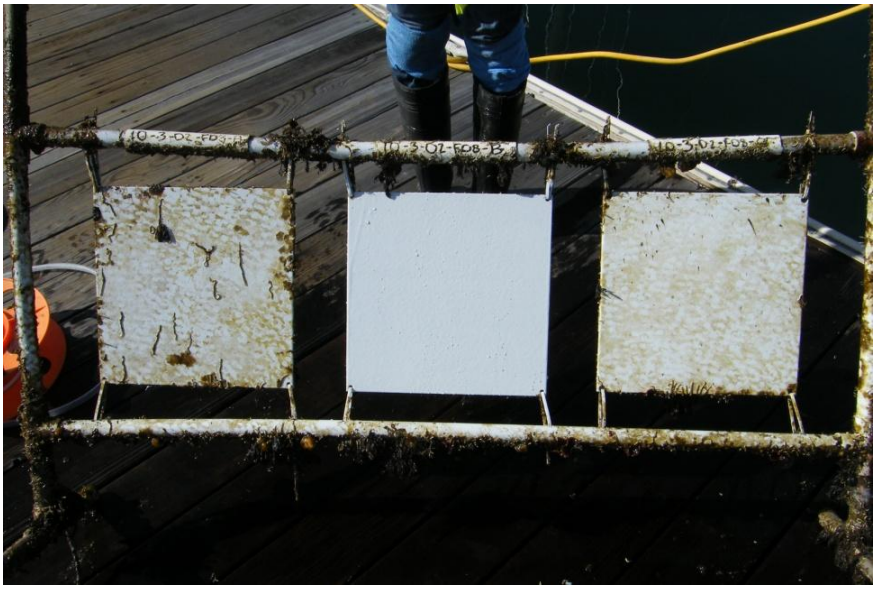
This paint did very well in the panel testing. Even the fouling ratings on the no clean panel and the two other panels prior to cleaning are low. The cleaning ratings are all low and the coating condition ratings are all low. A picture of the three panel assembly in January 2011 is shown in Figure 3-5. This paint was selected for boat testing because of its excellent performance in the panel testing. A Material Safety Data Sheet (MSDS) for the product, called Fujifilm Surface Coat Part A-Black, is shown in Appendix B.

Source: POSD, 2011
Figure 3-5. Sher-Release Paint During Panel Testing

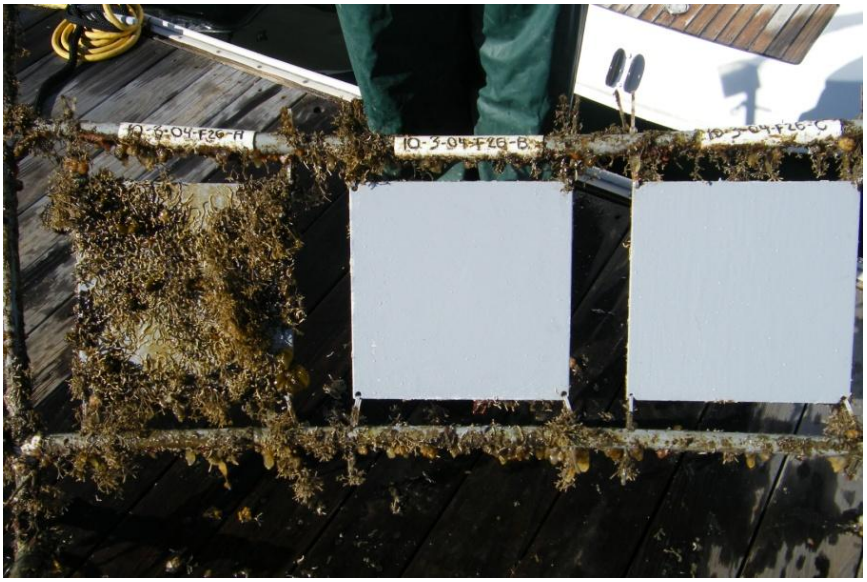
The panel testing data sheets in Appendix A show that the fouling ratings on the no clean panel are fairly high whereas the fouling ratings on the other two panels that were cleaned regularly are low. The coating condition on the panels that were cleaned is somewhat high (a few 2s and 3s on the data sheets). The notes indicate that the coating is scratched and this follows from the fact that the coating is very soft and easily removed. A picture of the three panel assembly for the paint in January 2011 is shown in Figure 3-6. This coating was selected for the boat testing phase and an MSDS for the product is shown in Appendix B. As discussed later, the company developed a hardener to add to the paint and it was more durable when it was applied to the boat with the hardener additive.

Source: POSD, 2011
Figure 3-6. XZM 480 Paint During Panel Testing

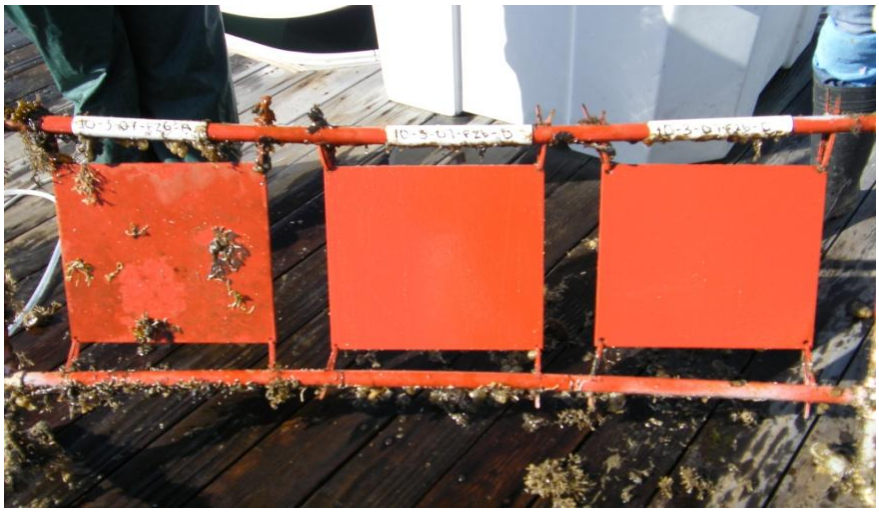
The panel testing data show that the fouling ratings on all three panels are very low for XA 278 which means the fouling levels are very good. Cleaning the panels was accomplished easily with soft tools. The company indicated the soft side of a sponge should be used and it readily removed the small amount of fouling that was present. The coating condition of all the panels was good. A picture of the three panel assembly for this paint in January 2011 is shown in Figure 3-7.

Source: POSD, 2011
Figure 3-7. XA 278 Paint During Panel Testing

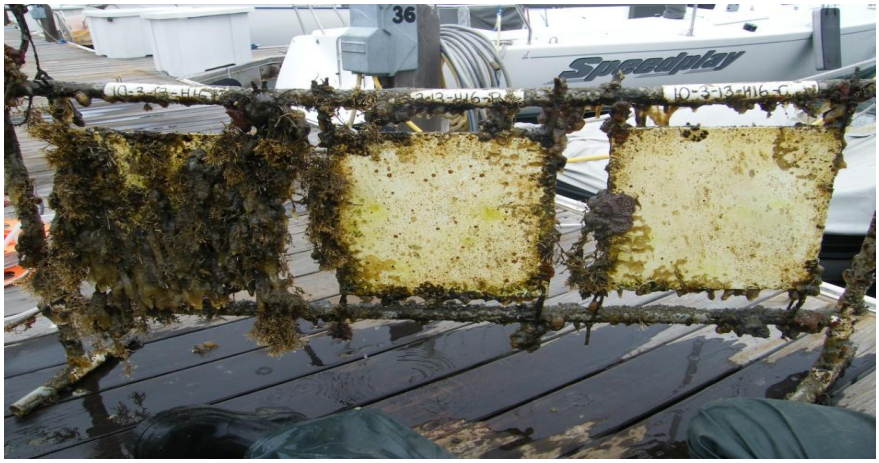
The same situation was apparent in the case of virtually all of the hard nonbiocide paints. Cleaning with the carpet could not adequately remove the fouling no matter how long the cleaning went on. Furthermore, aggressive and prolonged cleaning with the carpet would simply imbed the fouling into the coating rather than remove it. The panels would end up stained with fouling that could not be completely removed. Figures 3-8 and 3-9 show pictures of the three panel assemblies of hard nonbiocide paints with heavily stained middle panels. In addition, some of the coatings had to be scrubbed so hard that the coating was damaged. Cleaning with a more aggressive tool, like an abrasive pad, could remove the paint much more effectively. In some cases, however, even the more aggressive pad did not adequately remove the fouling and a periodic power tool cleaning would have helped considerably.

Source: POSD, 2011
Figure 3-9. Another Hard Nonbiocide Paint with Stained Middle Panel

Recall that the results of the Port/IRTA panel tests indicated that none of the hard nonbiocide paints performed well on the panels. It later became apparent why these coatings did not do well. The boat testing results from the earlier project clearly indicated that periodic power tool cleanings were necessary for hard nonbiocide paints.

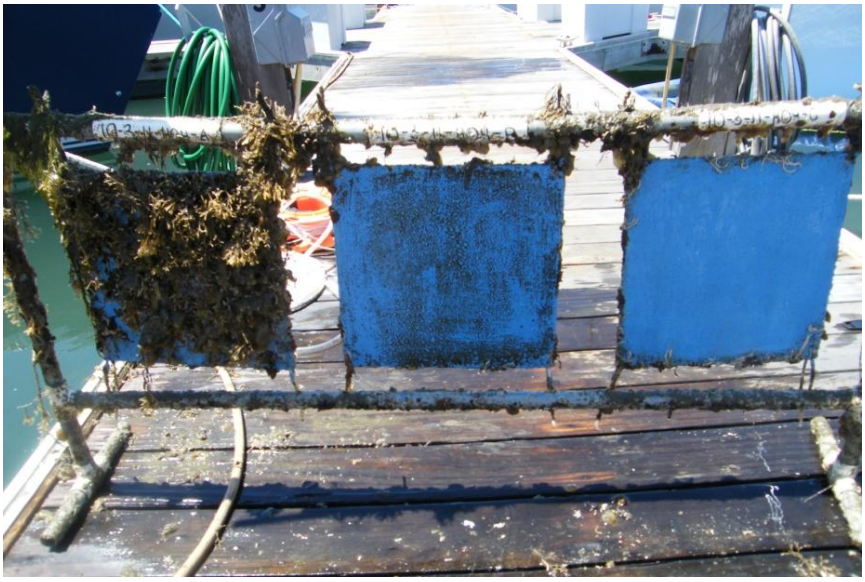
Source: POSD, 2011
Figure 3-10. HullSpeed 3080 Paint During Panel Testing

This paint, like the other Hullspeed paint described above, is a siliconized epoxy. It became very stained on both of the panels that were cleaned and the coating was being removed on the manufacturer panel. This panel was cleaned with a green pad. The cleaning tool may have been too aggressive for the silicon compound in the paint or the repeated cleaning with a tool that was not aggressive enough may have been the reason for the paint failure.

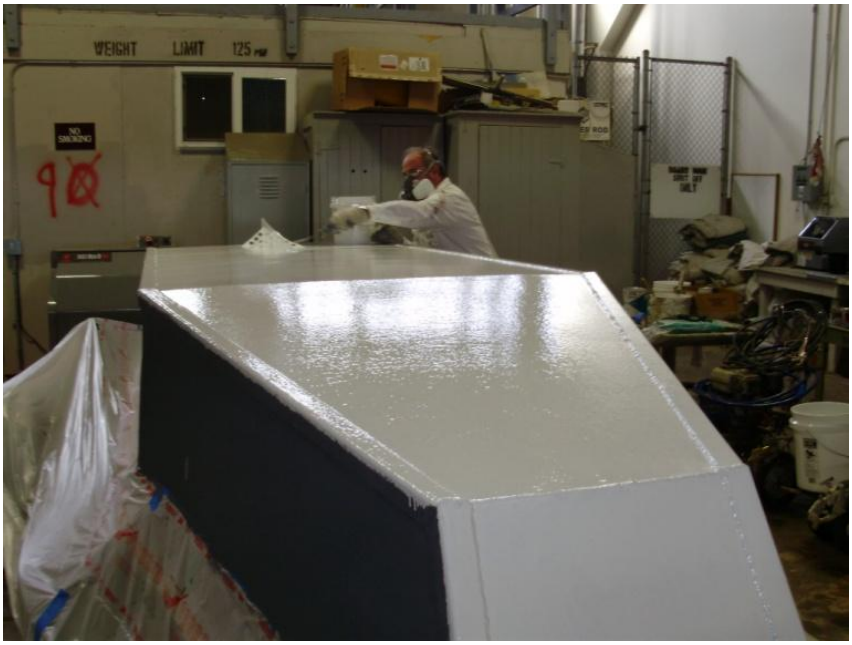
Figure 5-10. Port of San Francisco Workboat During Painting

The paint was applied to the boat in October 2011 by the Port paint shop. Figure 5-10 is a picture of the boat during the painting process and Figure 5-11 shows the boat with the new paint job. Two coats of a primer, one tiecoat and two topcoats were applied. The boat was launched in mid-October.

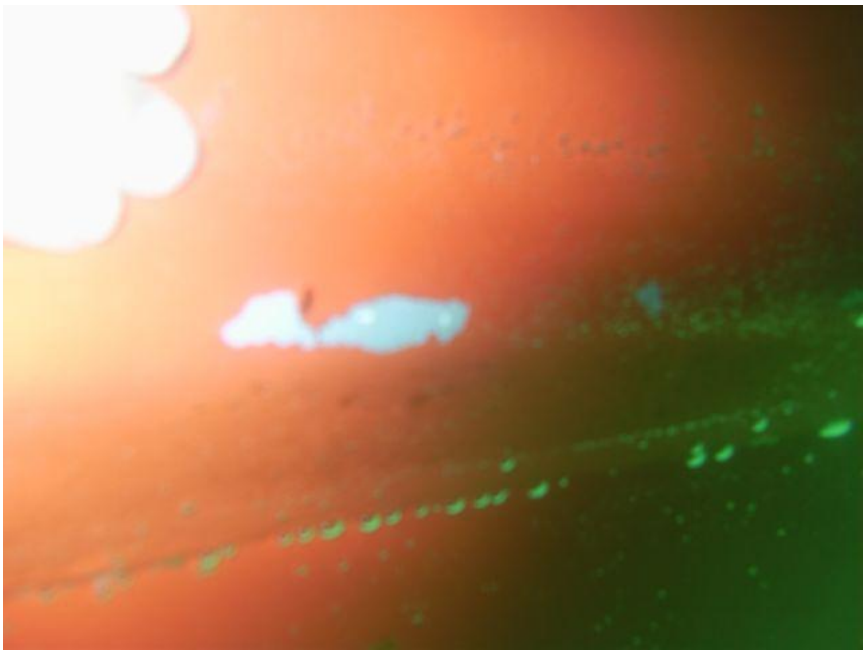
The boat was cleaned again in September and the diver observed three spots on the hull where the paint was peeling off. An underwater picture of the hull with the spots where the paint is peeling is shown in Figure 5-24. Another underwater picture of peeling paint in a different hull location is shown in Figure 5.25. According to the diver, one of the spots was a result of wax paper being removed during the paint job; paint was pulled off with the paper. The diver could initially see some wax paper on the

Figure 5-24. Underwater Picture of Peeling Paint

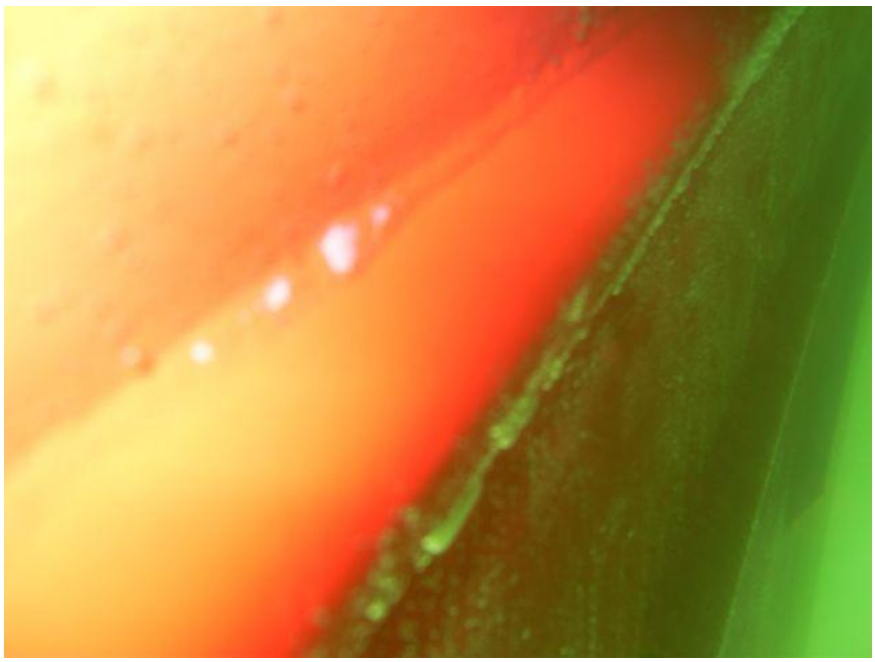
Figure 5-25. Underwater Picture of Paint Peeling in a Different Location

hull at this location. The diver also indicated the boat took a lot of effort to clean because the terry towel was so small. IRTA suggested the diver use a thin white pad for cleaning the boat when it was heavily fouled during the summer months. In October when the boat was cleaned, this time with a thin white pad, the same peeling spots were observed by the diver.
