A Guide to Mercury Assessment and Elimination in HealthCare Facilities

DEPARTMENT OF HEALTH SERVICES

Diana M. Bontá, R.N. Dr.P.H., Director
DEPARTMENT OF HEALTH SERVICES
September 2000

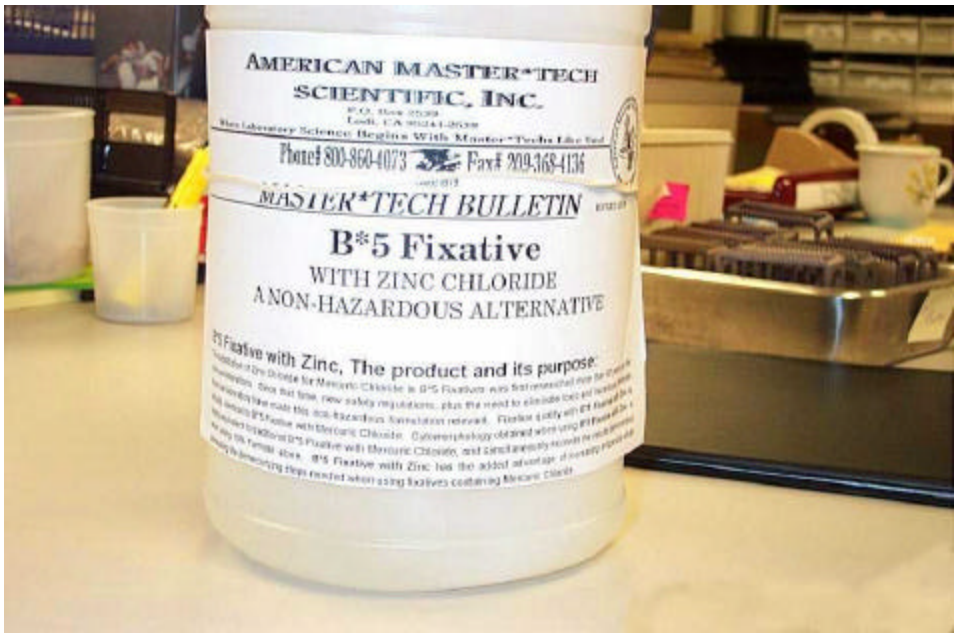
One of the compounds widely used in laboratories is B-5 fixative. This mercury-containing fixative has been used in histology to aid in identification of certain cell types. The tissue would be placed in a container with the B-5 fixative and left until the solution had penetrated the tissue. Then the tissue would be stained and placed onto a slide for microscopic examination. During the rinse process some mercury was discharged into the facility sewer system.

Figure 12 **"B-5" Fixative previously containing mercuric chloride has been replaced with zinc chloride as noted on the label. (Pollution Prevention Project Photograph)**

Several brands of B-5 fixative have been developed using zinc chloride instead of mercury. Laboratory suppliers should be able to provide a listing of possible substitute brands.

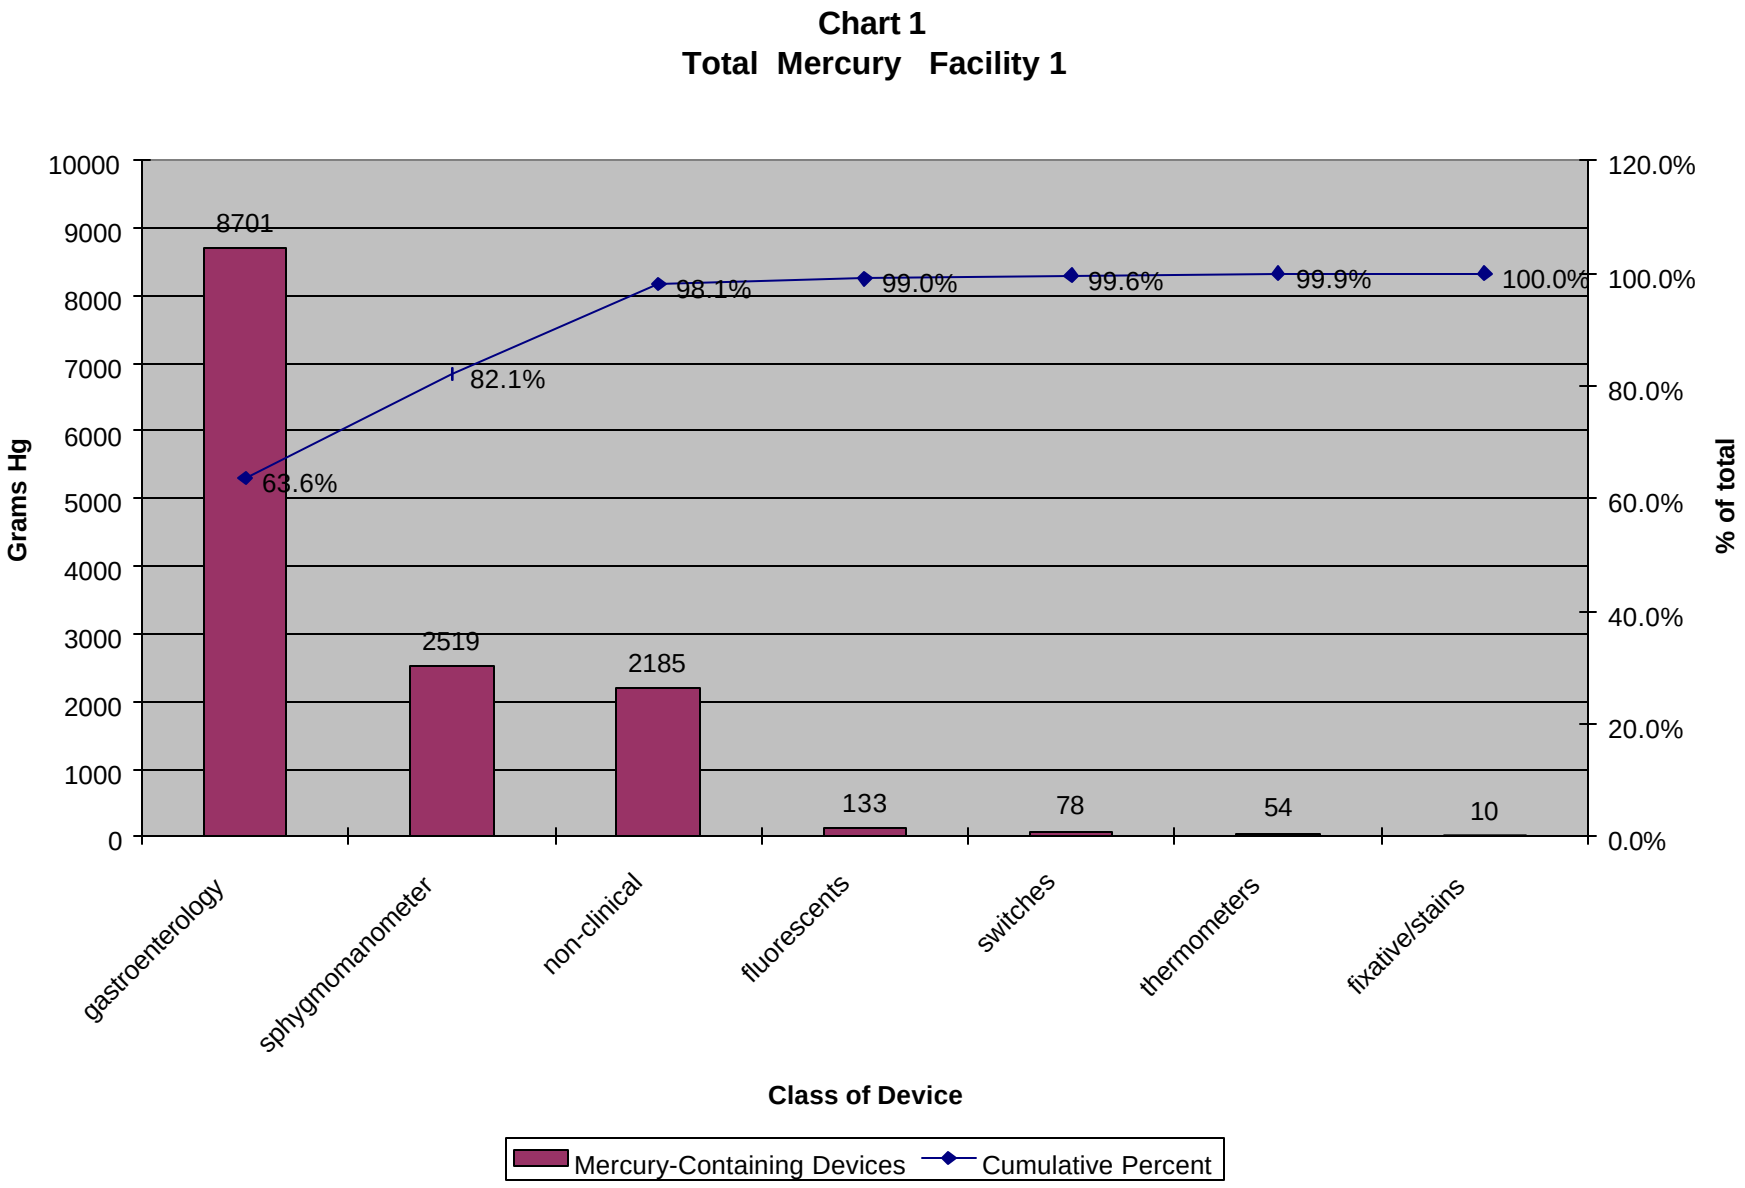
CHART 1. Total mercury (in descending quantity), by class of device or use, plotted vs. cumulative percentage. (Pareto Chart)

Sphygmomanometers made up the next highest percentage of mercury in the facility. In-place mercury sphygmomanometers make up slightly over 15 percent of all facility mercury, a total of 2.4 kilograms. Most of the mercury sphygmomanometers were found in the Coronary Care and Intensive Care Units, while some were found in Outpatient Surgery and the Emergency Room.

Mercury in fluorescent tubes used for lighting represented less than 1 percent of in-house mercury, about 133 grams. This mercury is contained in fluorescent tubes and would only be released if the tubes were broken. The Engineering Department retains original packing sleeves and boxes, and compacts intact boxes of used tubes for disposal. Effective March 7, 2000, DTSC adopted emergency regulations that require all fluorescent tubes be either recycled or disposed of as hazardous waste. Recycling this waste stream would bring the facility into compliance with this new regulation while also reducing this mercury waste stream.

TABLE 1. Mercury assessment data. Facility 1.

The mercury sources found at Facility 1 are entered below in the same order as they are shown in Chart 1. As can be seen from the cumulative percent plot on that chart, replacement with non mercury-containing items for the first three classes of devices shown as: (GI Devices, Sphygmomanometers, and the "non-clinical" class (barometer and bulk mercury) will result in a greater than 99 percent reduction of the mercury inventoried, at Facility 1.

- **Bougies.** Facility 1 has already earmarked mercury bougies for replacement with tungsten gel devices. The mercury bougies should be returned to the manufacturer according to existing protocol when their service date is reached. The cost to replace a set of bougies is approximately $3,000. Because the hospital has already replaced one of its two sets of bougies, the total expense for bougie replacement would be $3,000.

- **Other GI:** Non-mercury substitutes for many other gastroenterologic devices are in place. Blakemore tubes which use a dense rubber end, rather than a mercury-weighted end, are available to replace the four mercury-containing tubes that were inventoried. Their individual cost is $202; total replacement would be $808.

- **Sphygmomanometers:** The survey revealed that Facility 1 had replaced all but about 30 of its mercury sphygmomanometers. Replacement of the remaining sphygmomanometers is expected to continue and should not cost more than $148.50 per unit. The total amount required to implement this portion of the Business Plan would be $4,455. Proprietary exchange agreements are available that will take care of the disposal of removed mercury units and recycling of the mercury. Facility 1 should explore the feasibility of using such an arrangement for replacing their mercury sphygmomanometers.

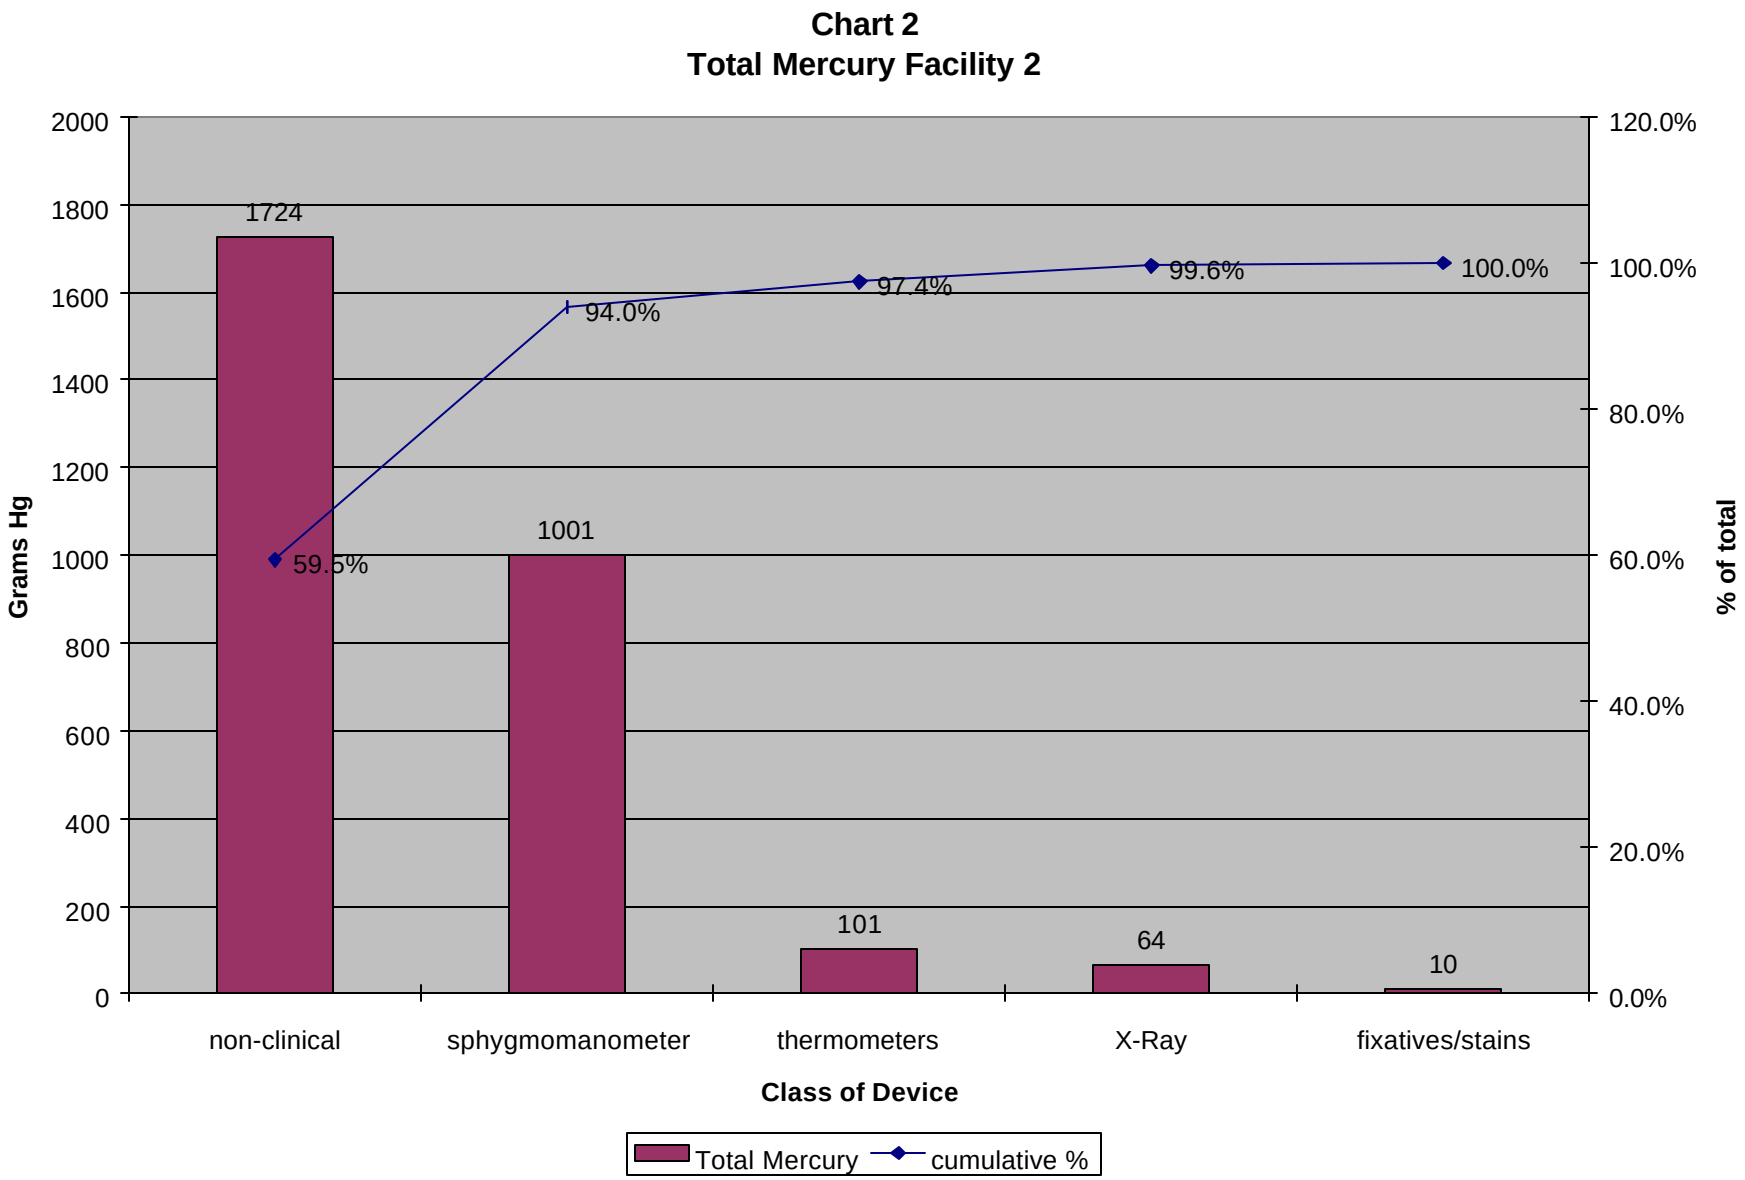
CHART 2. Total mercury (in descending quantity), by class of device or use, plotted vs. cumulative percentage. (Pareto Chart)

TABLE 2. Mercury assessment data. Facility 2.

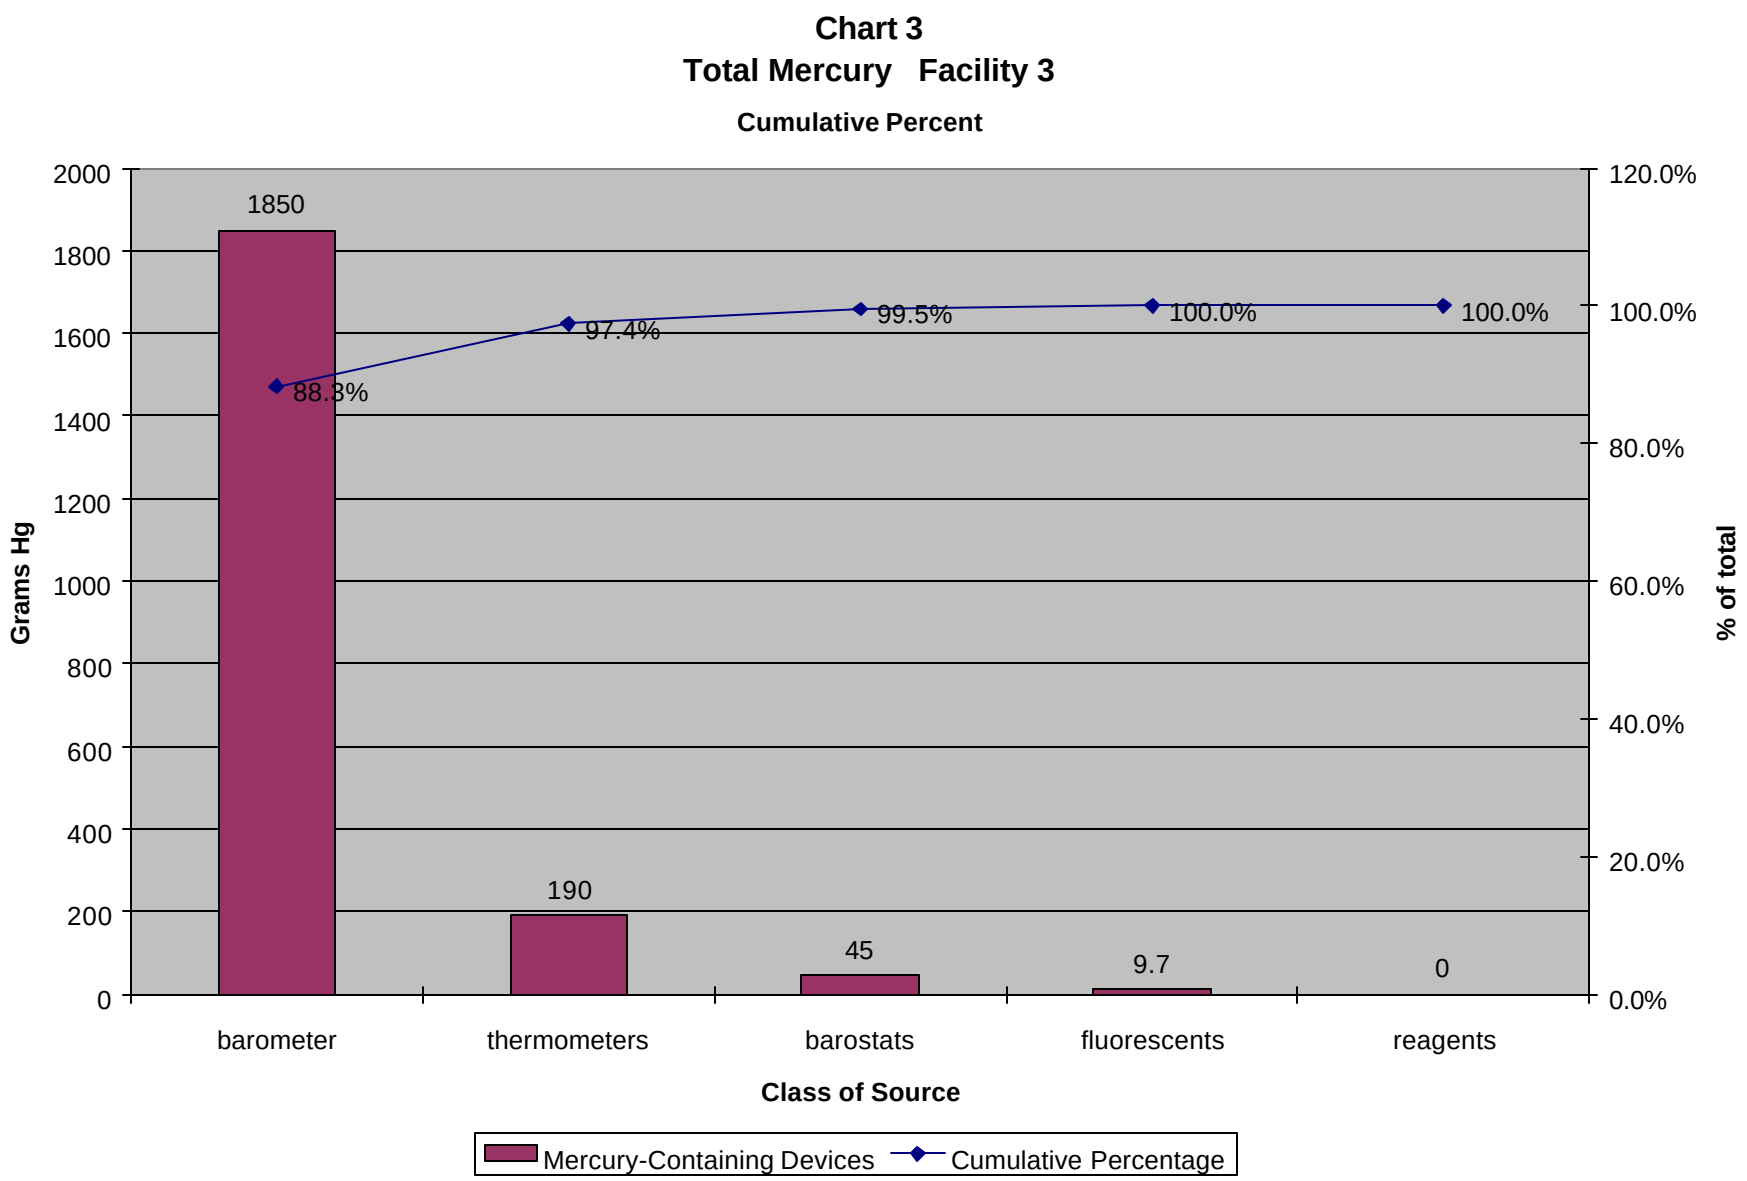
CHART 3. Total mercury (in descending quantity), by class of device or use, plotted vs. cumulative percentage. (Pareto Chart)

TABLE 3. Mercury assessment data for Facility 3.

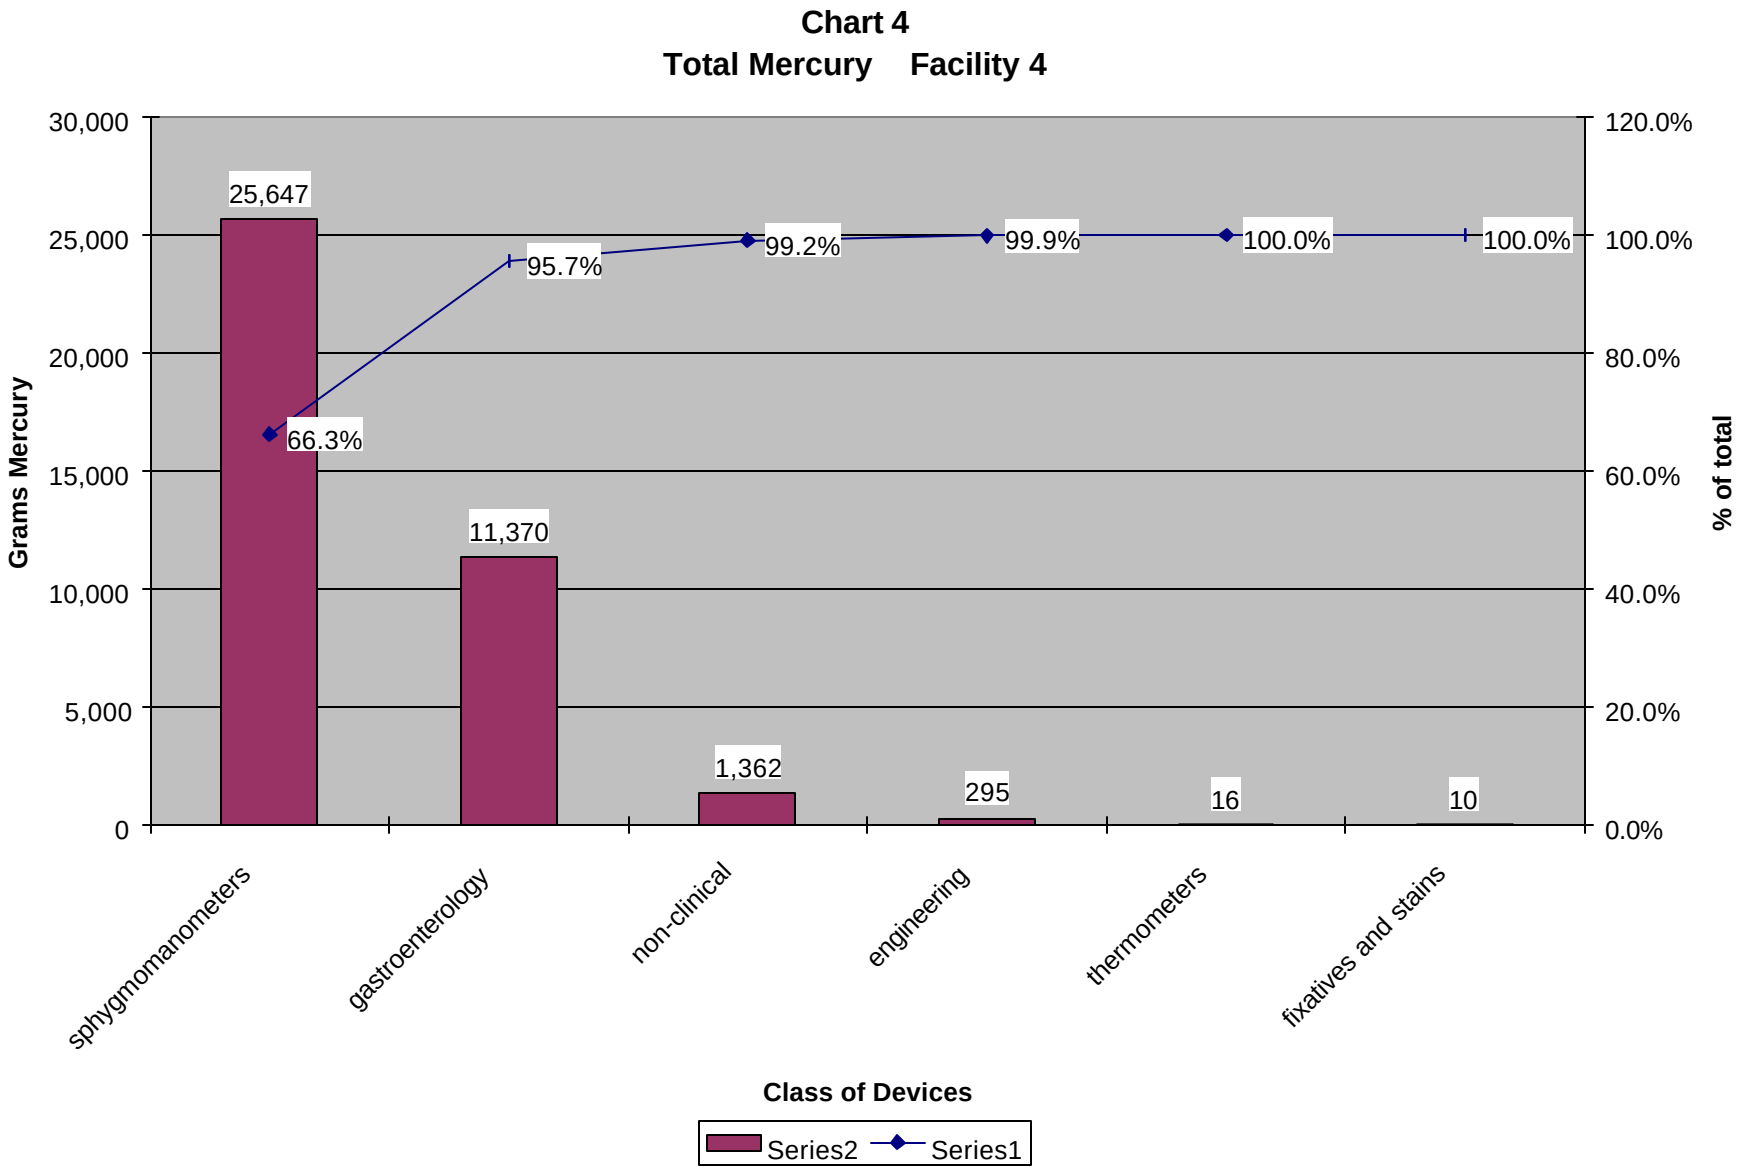
CHART 4. Total mercury (in descending quantity), by class of device or use, plotted vs. cumulative percentage. (Pareto Chart)

TABLE 4. Mercury assessment data for Facility 4.

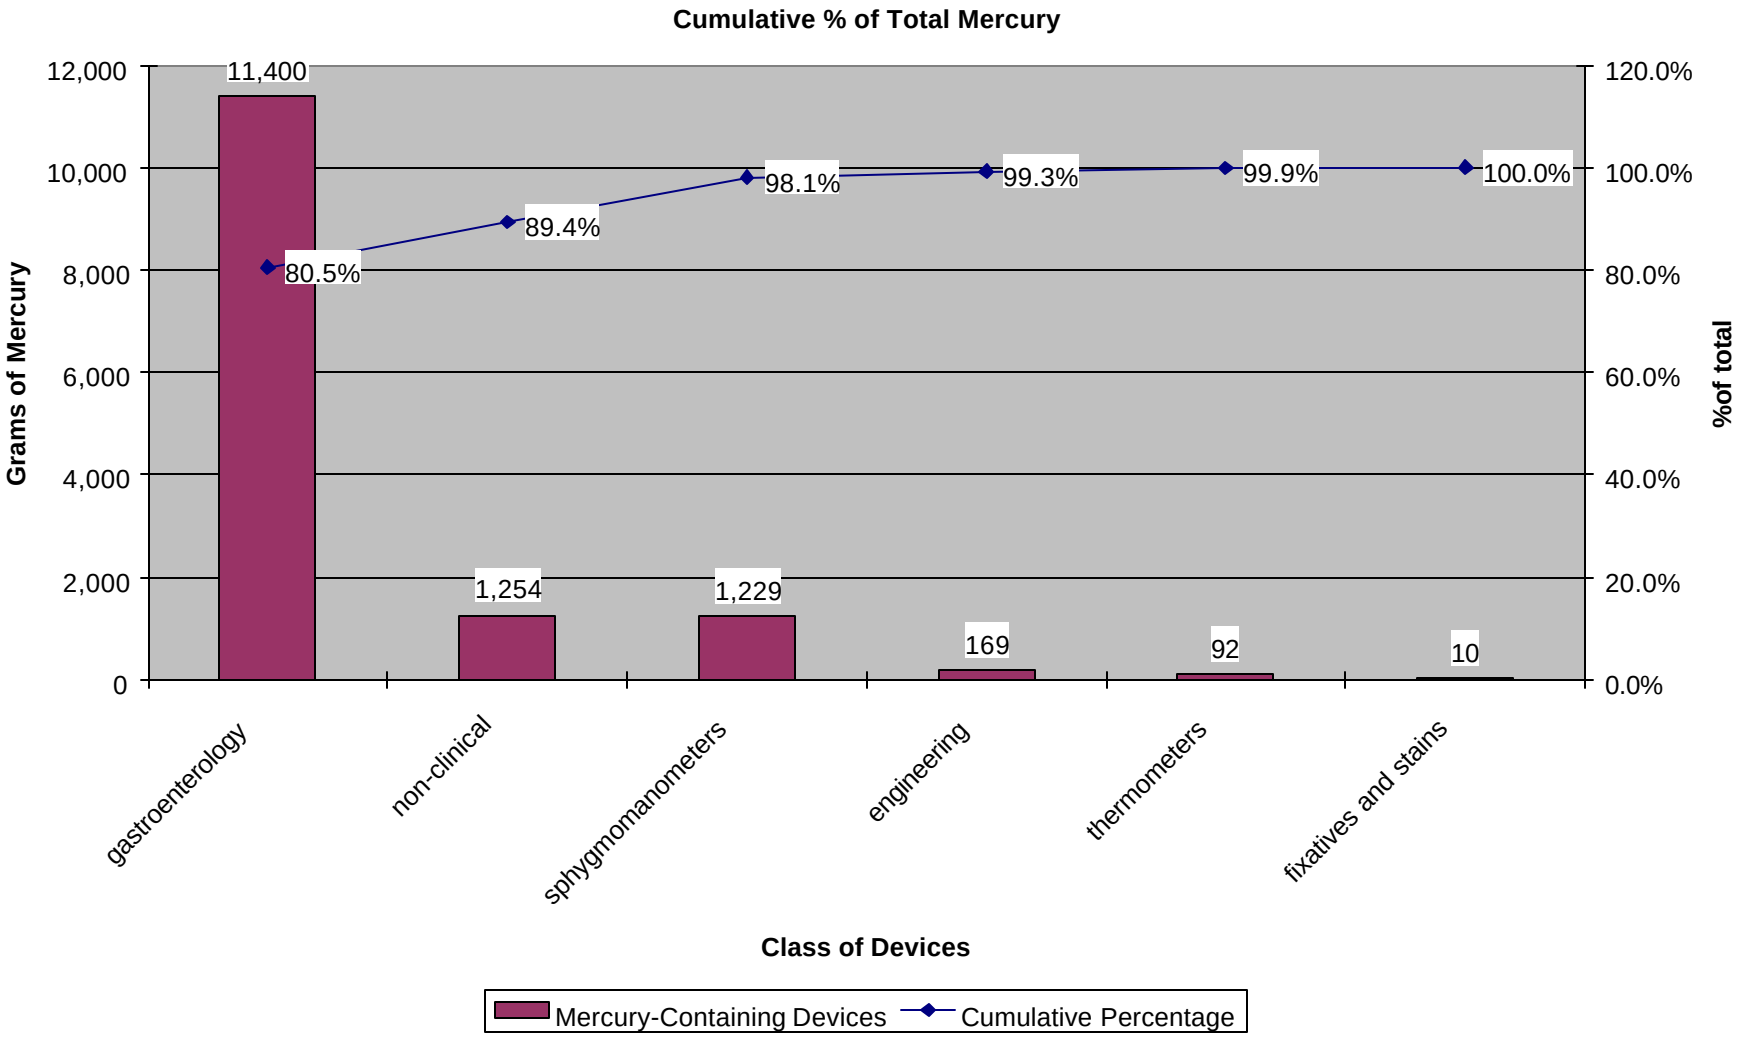
Chart 5
Total Mercury Faciltiy 5

TABLE 5. Mercury assessment data for Facility 5.

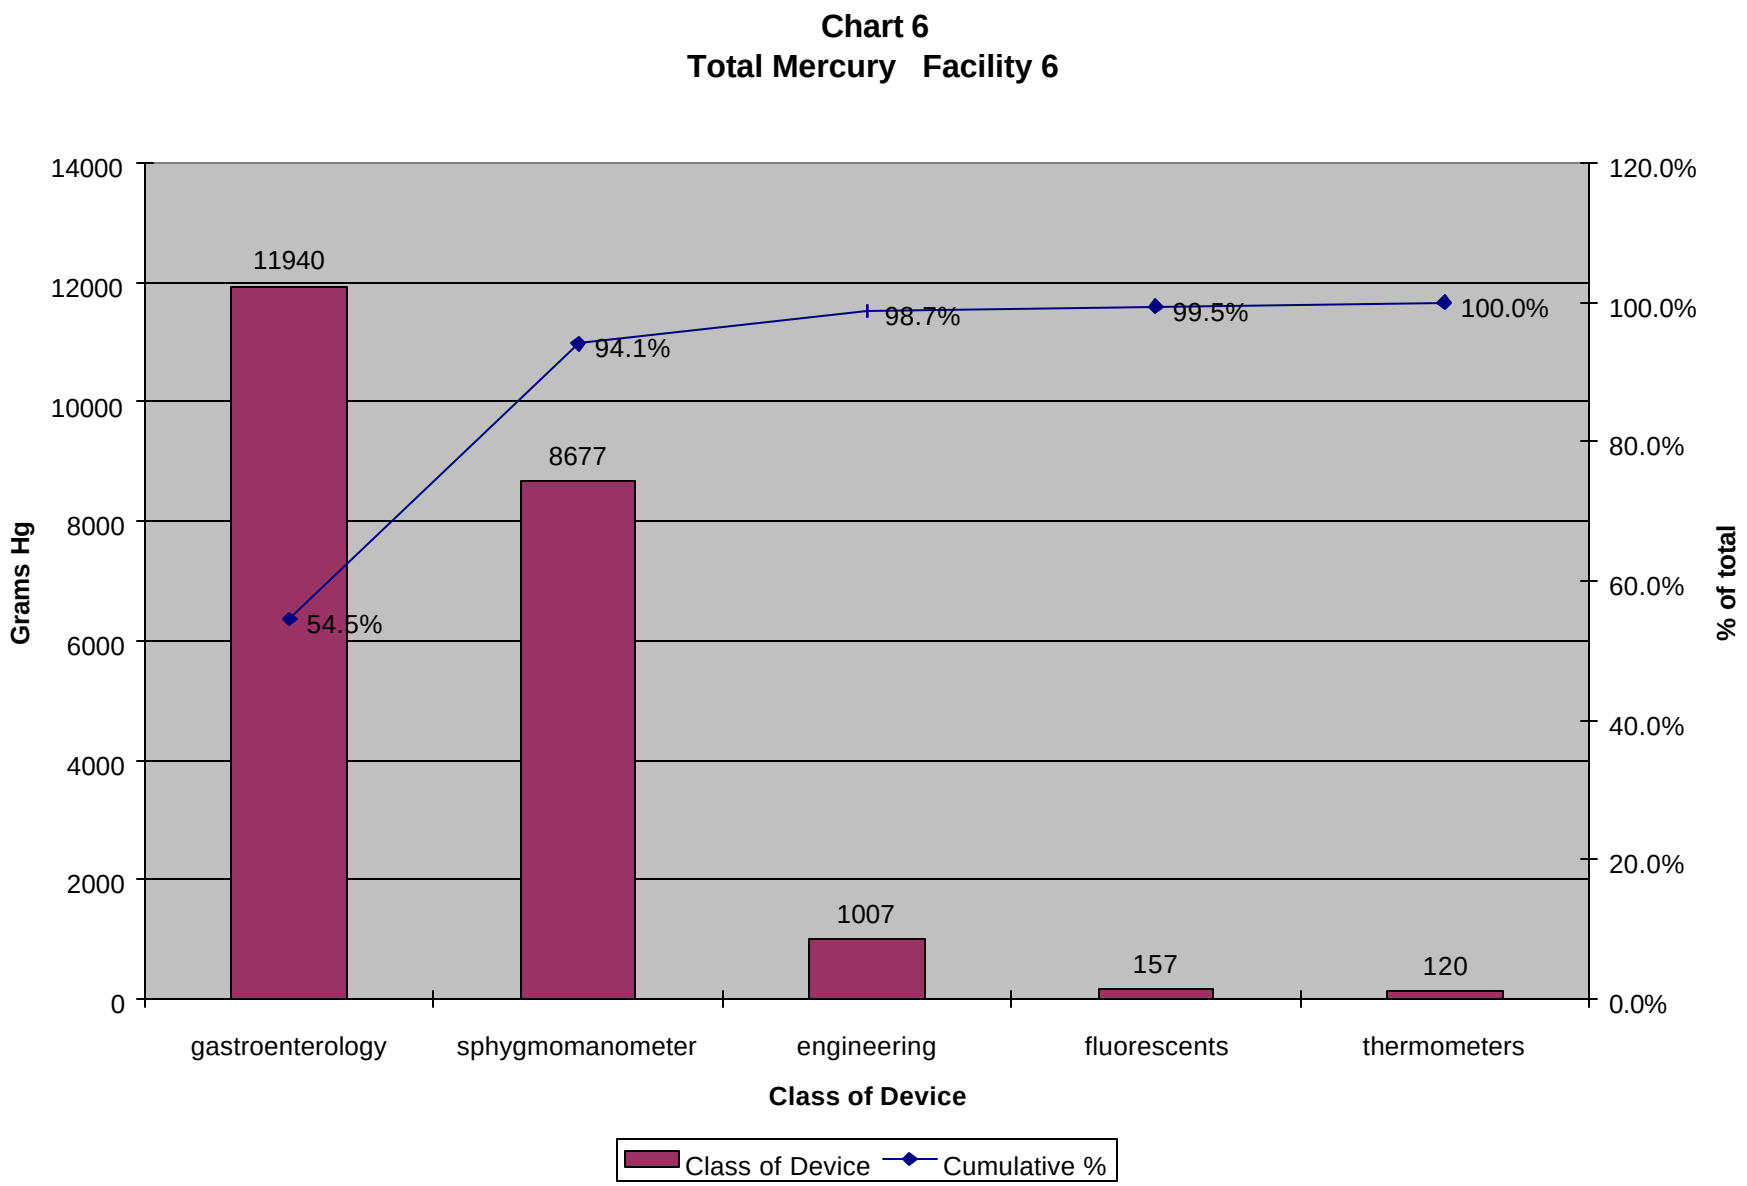
CHART 6. Total mercury (in descending quantity), by class of device or use, plotted vs. cumulative percentage. (Pareto Chart)

TABLE 6. Mercury assessment data for Facility 6.

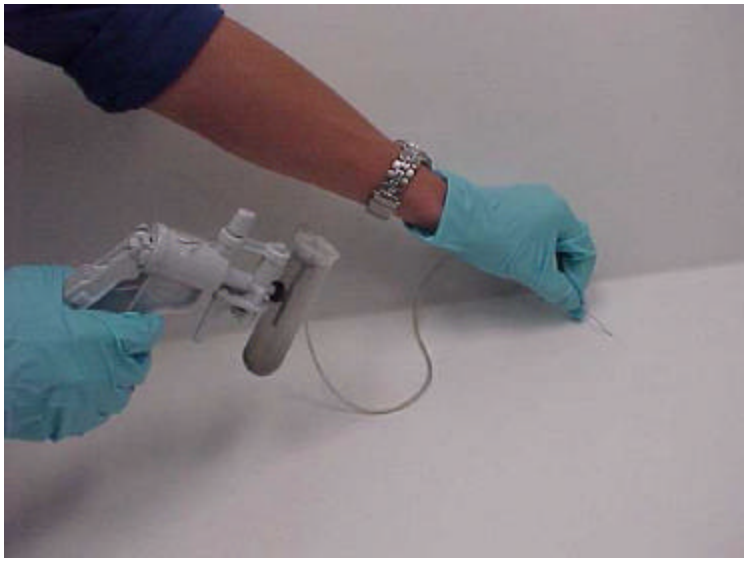
Figure 22 Micro vacuum being used to pick up spilled mercury. (Photo courtesy of UCLA, Office of Environment, Health & Safety)

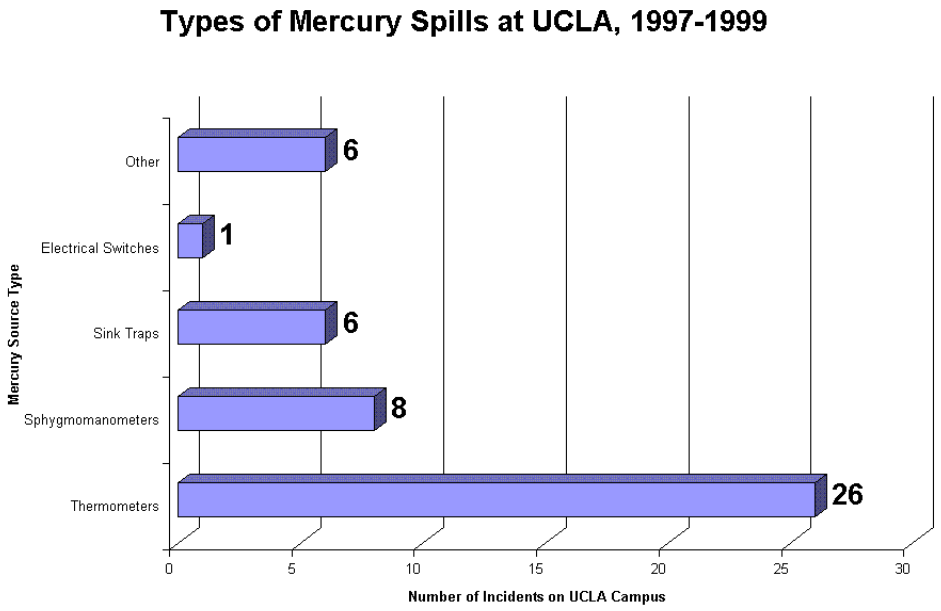
A total of 47 mercury spills were recorded on the UCLA campus from 1997 through 1999. A breakdown of the sources of these spills is presented in Figure 23. As can be seen from the data presented in Figure 23, thermometers accounted for 26 (55.3 percent) of the incidents. Sphygmomanometers were the second most frequent source of mercury spills during the 1997-99 period with eight spills representing 17.0 percent of the total events. Sink traps accounted for six mercury spills, including the CHS event, which represented 12.8 percent of the incidents. It is interesting to note that 42 percent of the hazardous materials incidents responded to by the UCLA Haz Mat Unit involve mercury. The UCLA Haz Mat Unit expended 280.59 hours responding to hazardous waste incidents during the years 1997-99. The personnel costs for the Haz Mat Unit are computed at $100 per hour resulting in a cost of $28,059 for the three year period.

Figure 23 Mercury spills on UCLA campus 1997-99 by source type. (Graph courtesy of UCLA, Office of the Environment, Health & Safety)
