IRTA

Fact Sheet, February 2012

Department of Toxic Substances Control

Alternative Boat Hull Paint Stripping Methods

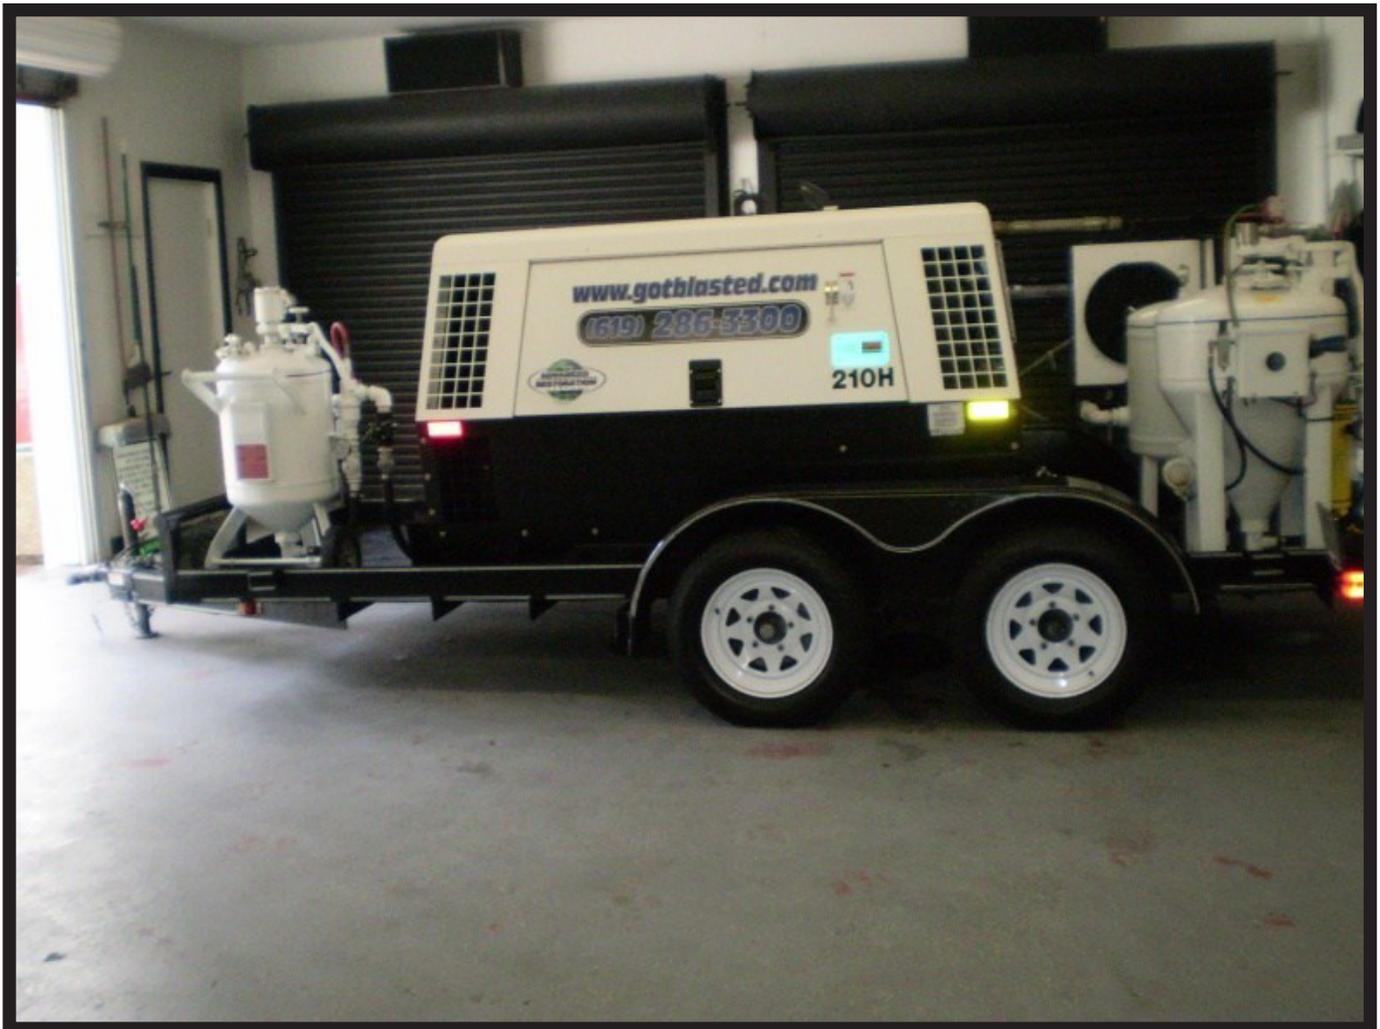
To test the alternatives, IRTA arranged for three technology vendors to demonstrate their technology for stripping small sections of a boat that was destined to be demolished at Marine Group, a boatyard in Chula Vista, California. One of the vendors, Advanced Restoration, offers a boat stripping service using dry sodium bicarbonate blasting media to boatyards in Southern California. The company also offers systems for sale to boatyards. This method is called soda blasting. When the company strips a boat, the boat is shrouded with plastic sheeting, the hull paint is stripped inside the shrouded area and Advanced Restoration collects the media for disposal by the boatyard. Several boatyards in Southern California have used Advanced Restoration's services.

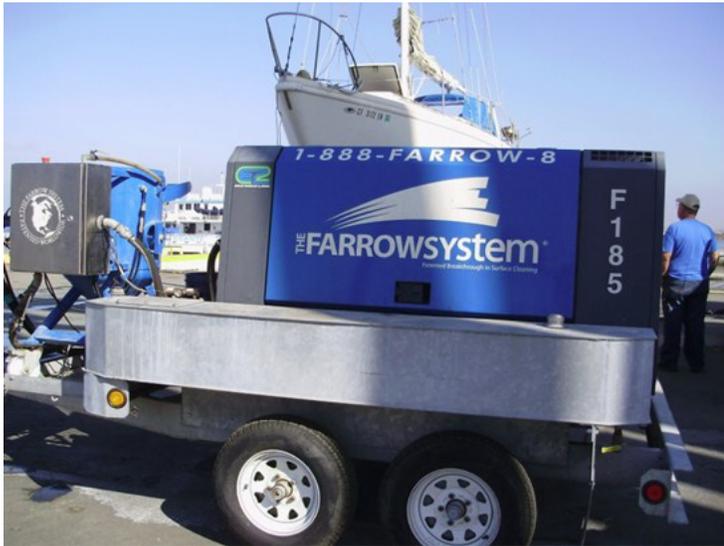
The second method relies on wet volcanic rock as the blasting media. A company in San Diego called Hawthorne represents a manufacturer of these systems and provides them for rent or sale. The Farrow system is a self-contained trailer mounted unit with its own air compressor and a 110 gallon water supply. The technology uses low pressure air, heat, water and the media for stripping. The company claims that containment is not necessary because the technology is wet. One of these systems has been sold to a boatyard in Southern California but there is little, if any, experience in this industry in using the technology.

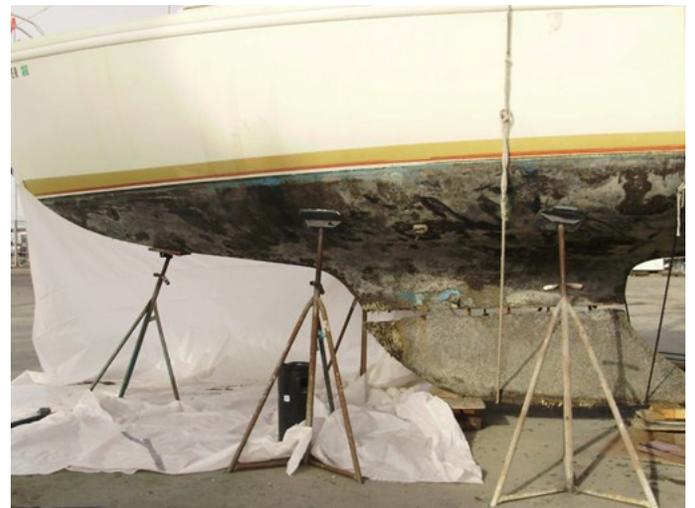
The third alternative stripping method is dry ice blasting that uses solid carbon dioxide accelerated at supersonic speed for blasting the paint from the boat. It is based on a Cold Jet System marketed by Red-D-Arc in the San Diego area. The advantage of this method is that the carbon dioxide sublimates or forms a gas and the only waste generated

from the process is the paint residue. Red-D-Arc offers these systems for rental or purchase. Like the volcanic rock technology, there is limited, if any, experience in this industry in using this technology.

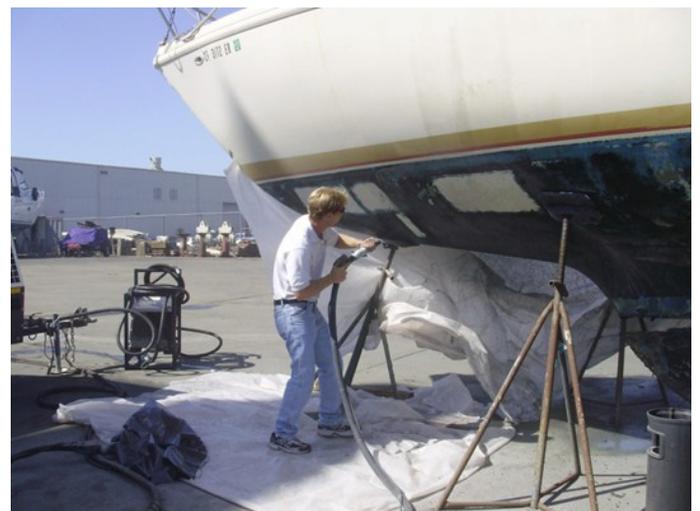
The demonstration involved stripping patches of a boat with old copper paint rather than an entire boat so the results are only qualitatively useful.

All three technologies successfully stripped paint from the boat. DTSC collected samples of the spent stripping media for analysis and all contained copper concentrations that indicated the residue would have to be handled as hazardous waste.
