DTSC Scores Goal on New Soccer Complex in Rancho Cordova

The San Juan Soccer Club proposes to build four soccer fields on a portion of the former Purity Sales – Delta Gunitite property at Kilgore and White Rock roads. The site was used for a variety of purposes, including oil recycling and waste disposal, until 1984.

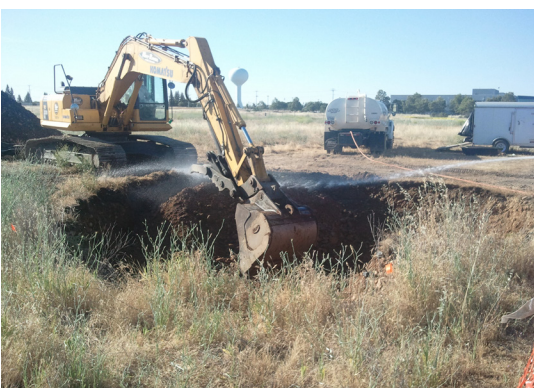
Left: A backhoe excavates contaminated soil. **Middle:** A roller compacts aggregate base over the cap area. **Right:** Workers use heat to seal the seams of a liner over the cap. The area will eventually become a parking lot.

The state Department of Toxic Substances Control (DTSC) supervised a cleanup of about 14 acres that included excavating 140 cubic yards of soil, confirmation sampling, backfilling and installing an asphalt cap and liner over a portion of the property. The soccer fields and accompanying parking lot – the parking lot will be atop the asphalt cap – are allowed under a land-use covenant DTSC required to minimize exposure and to prevent inappropriate land use.
