HALEY & ALDRICH AIBP SWMU 4.8 RFI WORKPLAN
BOEING SANTA SUSANA FIELD LABORATORY
VENTURA COUNTY, CALIFORNIA

**PROPOSED SAMPLING LOCATIONS
AREA I BURN PIT - SWMU 4.8**

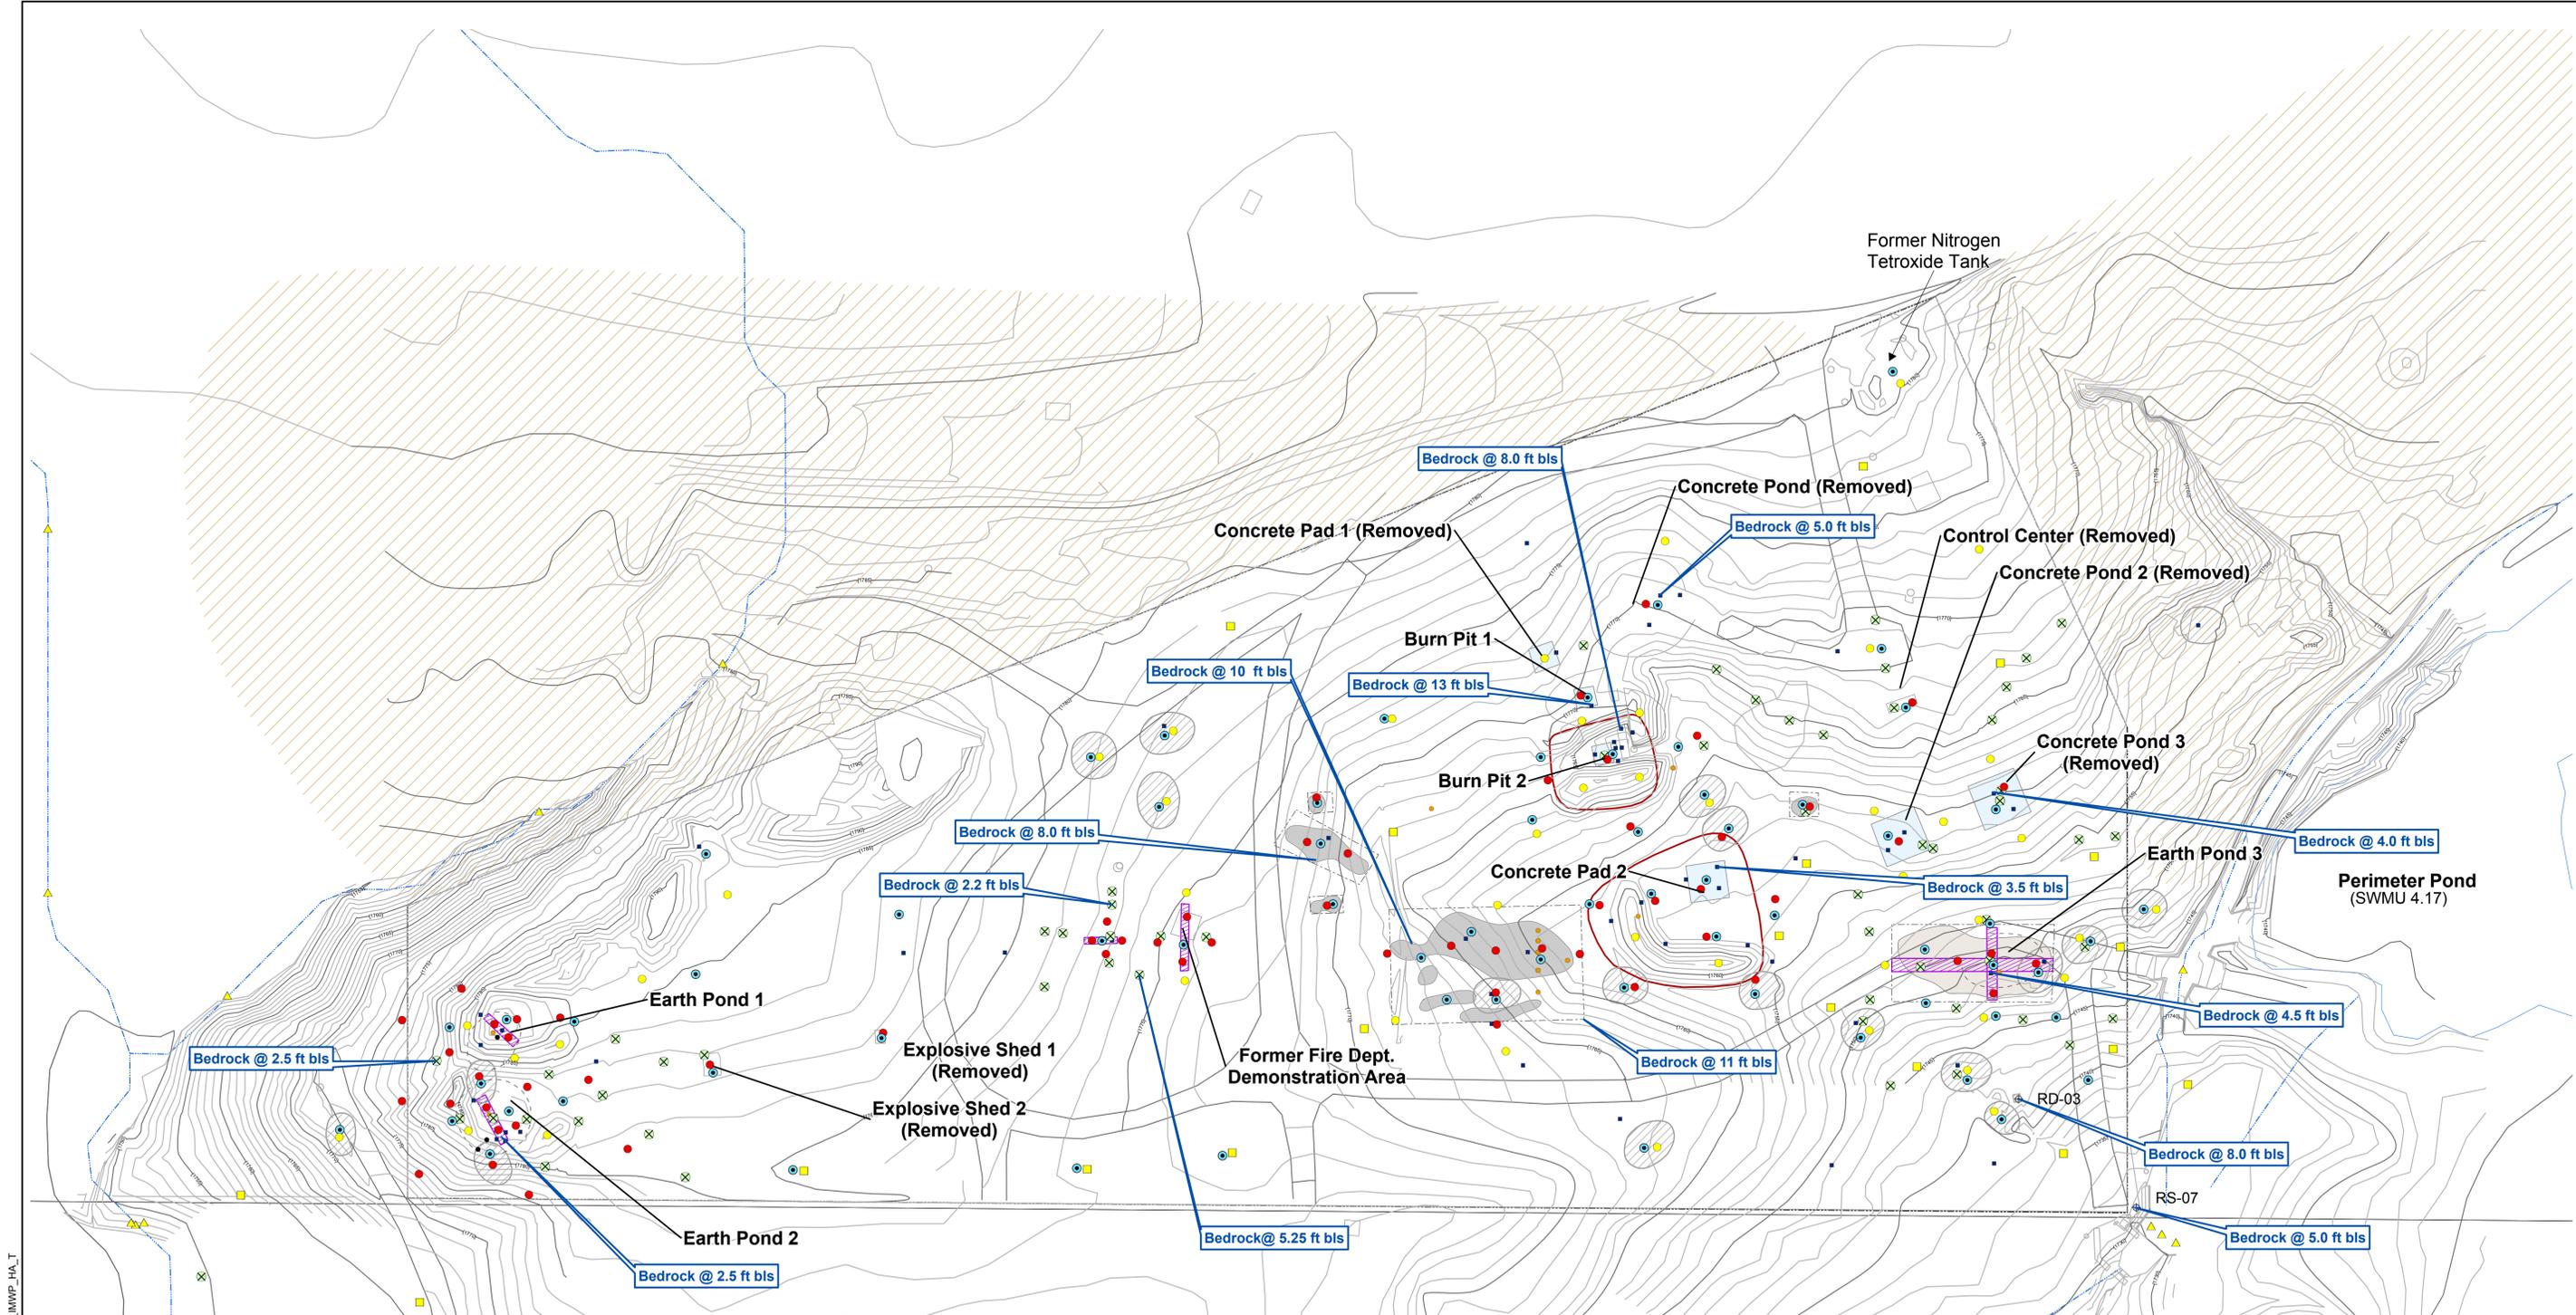
- Proposed Sample Locations:**
- Source Area Sample
 - ⊕ Soil Vapor Screening Sample
 - Disturbed Area/Operational Uncertainty Soil Sample*
 - Migration Pathway Soil Sample
 - ▲ Drainage Sediment Sample
- * Red indicates Comprehensive Analyte Suite and yellow indicates RFI Analytical Suite (described in Table IX)
